MEMORANDUM

TO: PORT LUDLOW DRAINAGE DISTRICT
FROM: STACEY CLEAR, P.E.
DATE: FEBRUARY 7, 2026
SUBJECT: 2026 FACILITIES INSPECTION RESULTS

2026 PLDD Area Inventory Inspection (February 6, 2026)

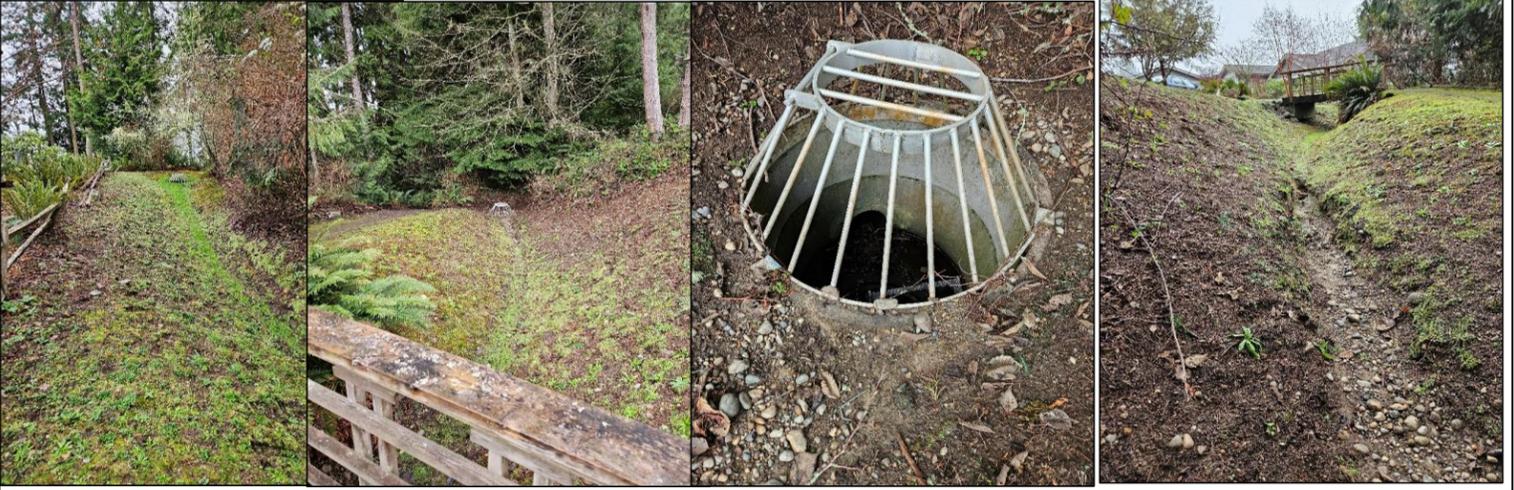
Area #	Parcel Number	Owner	Area Description	Facility Description, Documents, Photos	Maintenance Activities	Inspection Comments	Photos
1	968800100	Jefferson County	LUDLOW COVE DIVISION 1 PHASE 1 OPEN SPACE TRACTS A, B & C ASSESSED W/LOTS-End of Waterhouse Ln	Developer installed swale and outlet structure	Vegetation clearing	Channel just downstream of bridge is incised (Russ (Landscaper Maintenance Contractor) to add fill/rocks); Continue to monitor for sediment buildup in manhole, channel and overgrowth of vegetation.

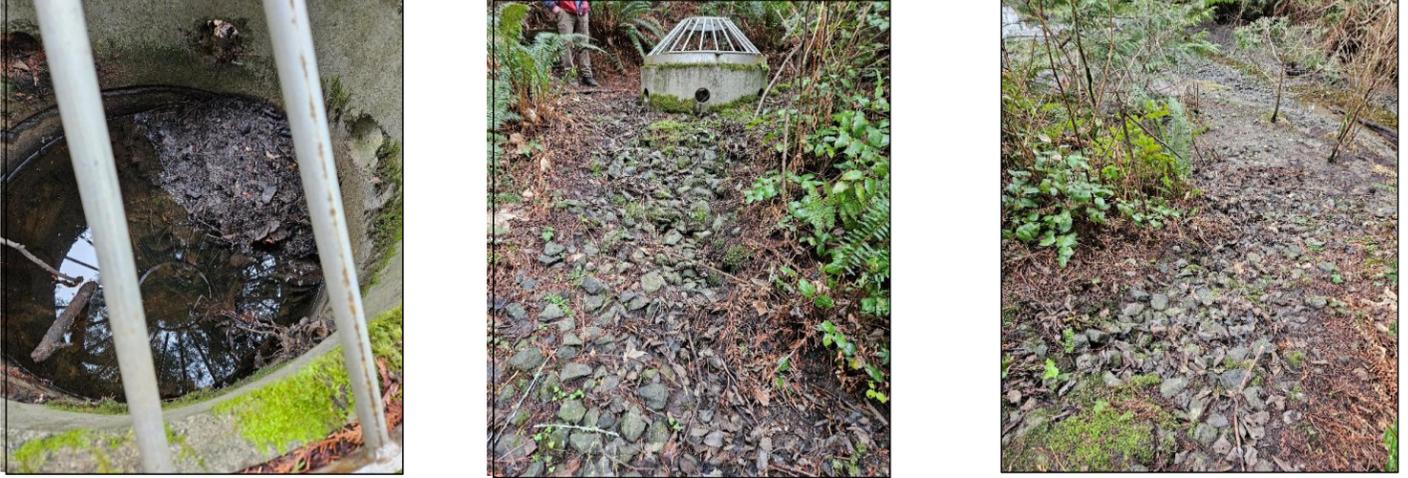
2	"	"	"	Outlet structure	Storm pipe/basin inspection/cleaning	Debris in outlet structure to be cleaned out; Continue to monitor debris in manhole and ensure rip rap downstream is in tact.

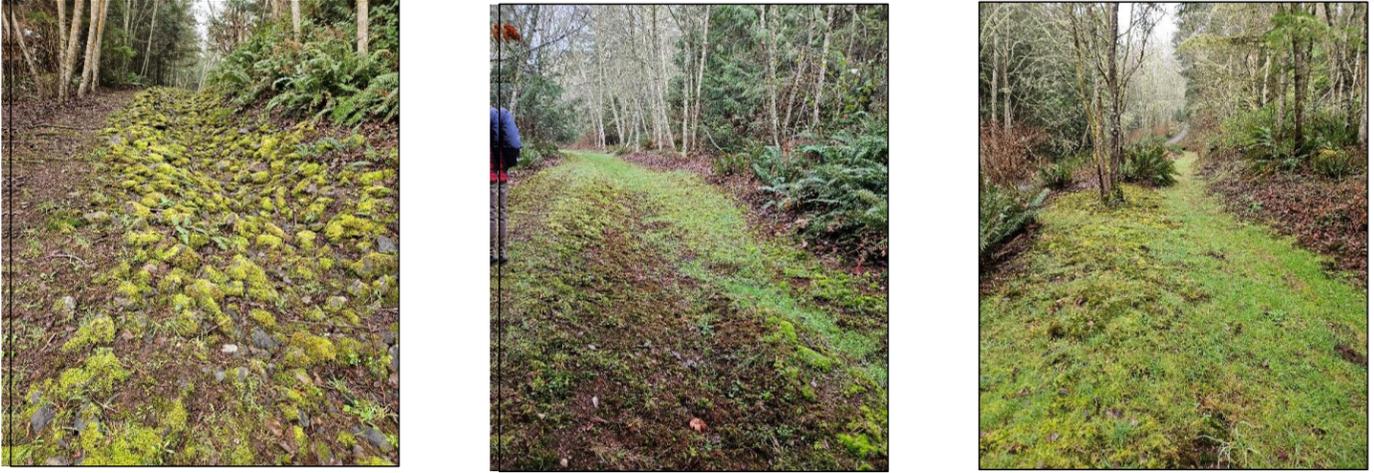
3	821171015	PLA	Bioswale Stormwater Facility west of Oak Bay Road across from Port Ludlow Condos	PLDD Project #2. Bioswale Stormwater Facility	Vegetation clearing	Area looked clean; continue to monitor vegetation overgrowth and debris buildup in the channel.

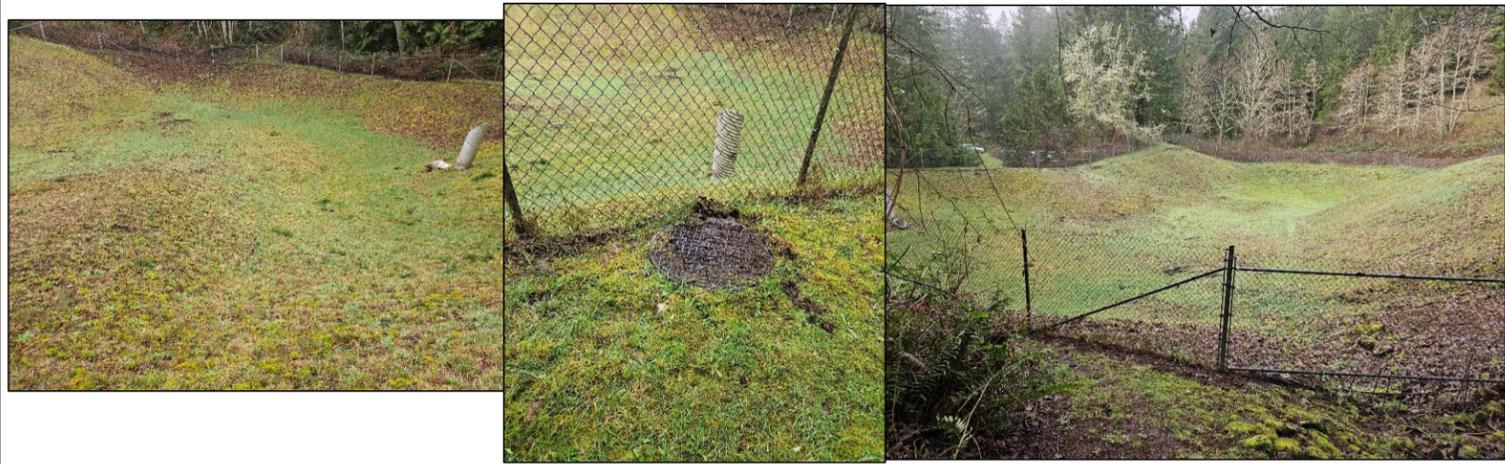
Area #	Parcel Number	Owner	Area Description	Facility Description, Documents, Photos	Maintenance Activities	Inspection Comments	Photos
4	"	"	Detention pond	Detention pond	"	Russ to inspect control structure manhole outside gate to ensure no debris is blocking anything; Pond was clean; Continue to maintain controlled vegetation within the pond and clear sediment over time.

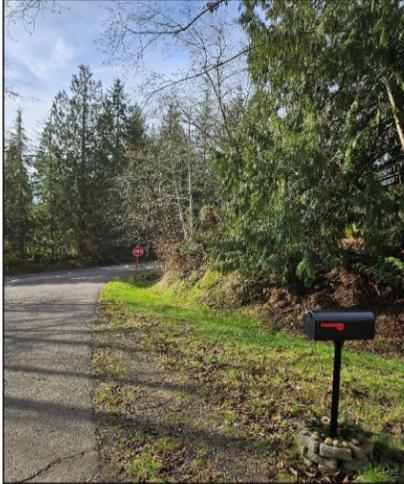
5	990500081	LMC	PORT LUDLOW NO. 4 RESERVE AREA LESS R/W - East end of Hummingbird Court	Open woodlands	Vegetation clearing	Ditches were adequate, Cul-de-sac not developed much so runoff not much of an issue. Russ checks a few times a year for channel debris.

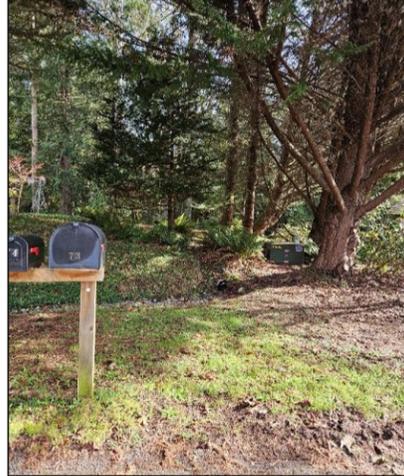
6	"	"	PORT LUDLOW NO. 4 RESERVE AREA LESS R/W - East end of Wren Court	Corrugated metal pipe	Vegetation clearing	Small chanelized area monitored downstream to handle runoff from cul-de-sac where numerous d/way culverts are often full.

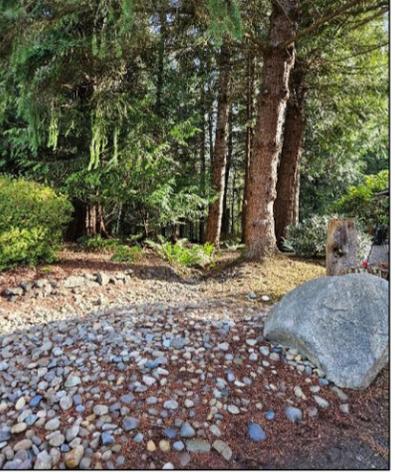
Area #	Parcel Number	Owner	Area Description	Facility Description, Documents, Photos	Maintenance Activities	Inspection Comments	Photos
7	"	"	PORT LUDLOW NO. 4 RESERVE AREA LESS R/W - East end of Sparrow Lane	Open ditch after driveway culvert	Vegetation clearing	Small chanelized area monitored downstream to handle runoff from cul-de-sac where numerous d/way culverts are often full.

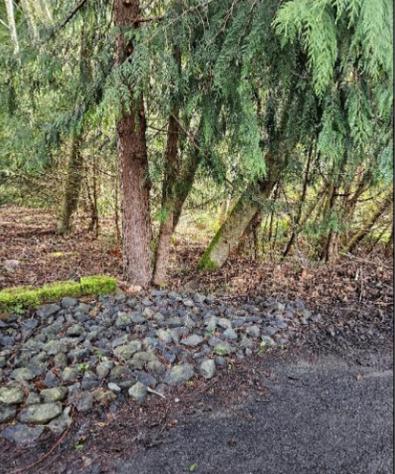
8	"	"	PORT LUDLOW NO. 4 RESERVE AREA LESS R/W - East end of Goldfinch Lane	Open ditch after driveway culvert	Vegetation clearing	Small chanelized area monitored downstream to handle runoff from cul-de-sac where numerous d/way culverts are often full.

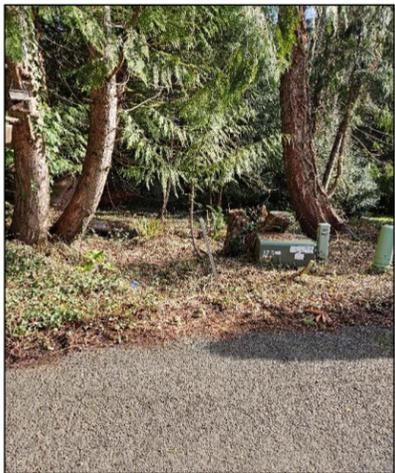
9	"	"	PORT LUDLOW NO. 4 RESERVE AREA LESS R/W - East end of Falcon Lane	Open ditch after driveway culvert	Vegetation clearing	Small chanelized area monitored downstream to handle runoff from cul-de-sac where numerous d/way culverts are often full.

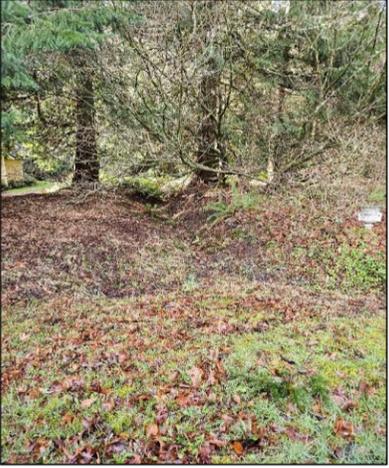
Area #	Parcel Number	Owner	Area Description	Facility Description, Documents, Photos	Maintenance Activities	Inspection Comments	Photos
10	"	"	PORT LUDLOW NO. 4 RESERVE AREA LESS R/W - East end of Warbler Lane	Open ditch after driveway culvert	Vegetation clearing	Small chanelized area monitored downstream to handle runoff from cul-de-sac where numerous d/way culverts are often full.

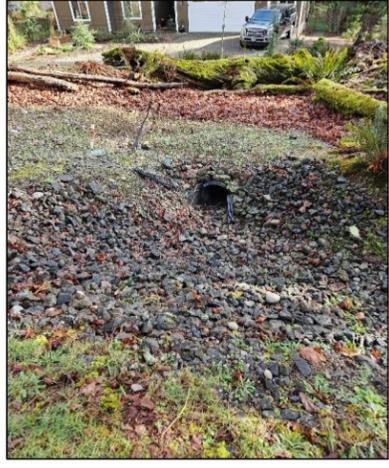
11	990400530	LMC	PORT LUDLOW NO. 1 AREA 5, RESERVE AREAS 1-4 TR 3. Parcel Drainage easement east of Machias	Machias Loop Conveyance Improvement	Inlet inspection/cleaning	Area was clean; Continue to ensure culvert area is open with no debris.

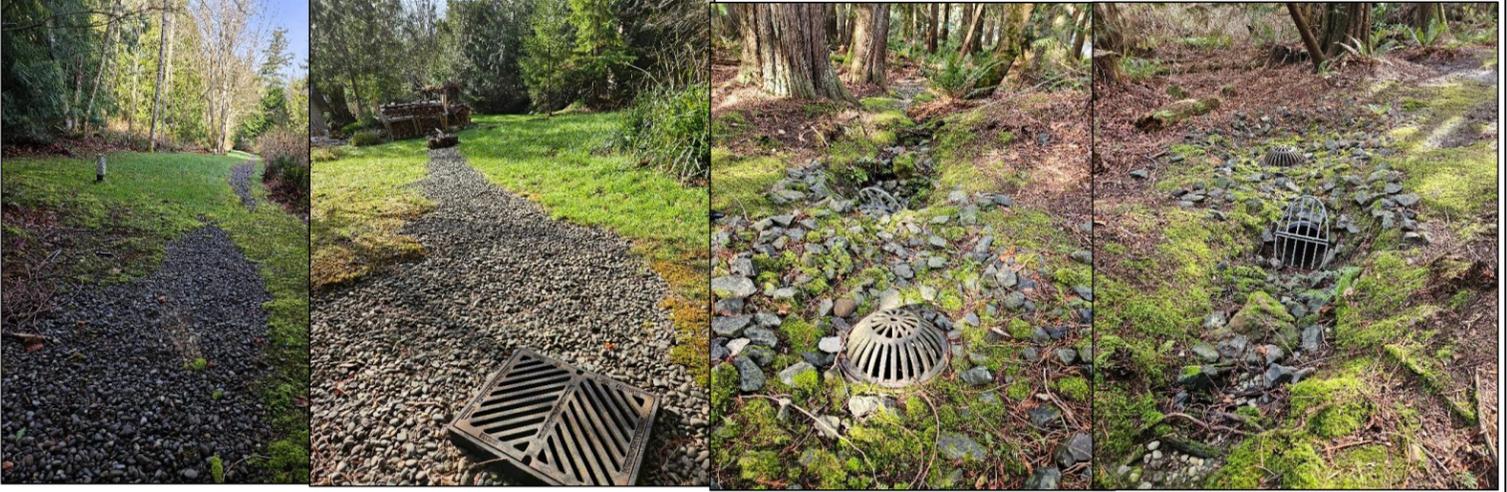
12	990404103 Covers several parcels North and South of Walker Way	LMC	Easement between Olympic Lane and Cascade Lane and Rainier trail on LMC greenbelt	PLDD Projects #7 & 18: French drain in easement. Drain basin off Rainier trail.	Light maintenance, Drain basin: clear leaves/debris 4x/yr	Full area was clean; Continue to keep debris from French drain, culvert/beehive entrances and check sediment buildup near the culverts.

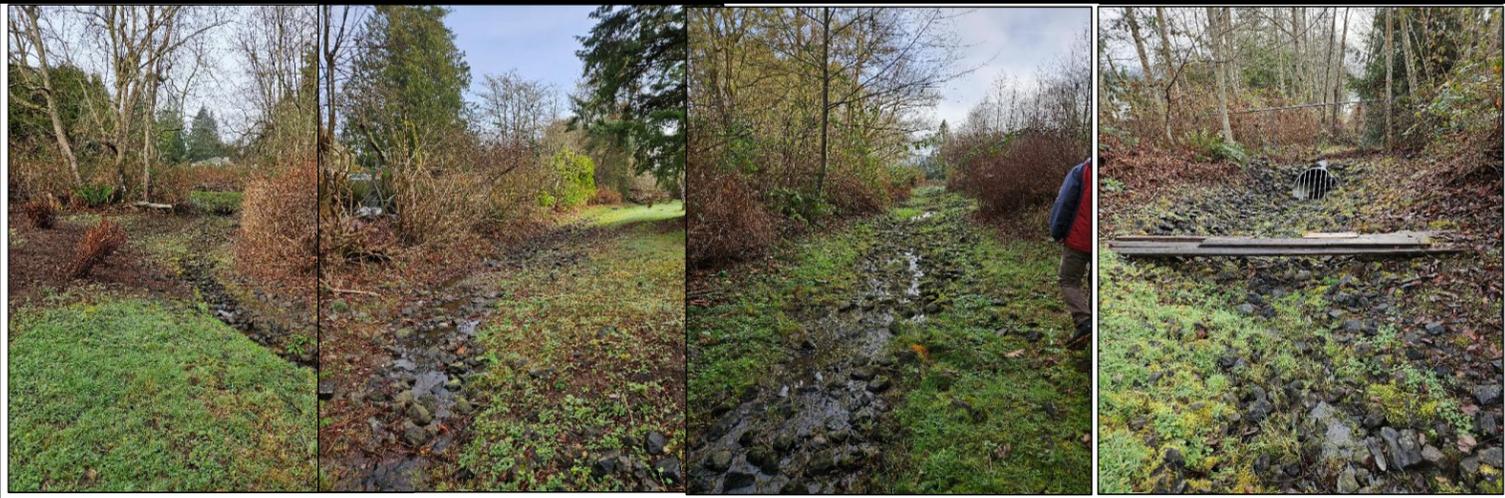
Area #	Parcel Number	Owner	Area Description	Facility Description, Documents, Photos	Maintenance Activities	Inspection Comments	Photos
13	821093001	PLA	Easement west of Waste Water Treatment Plant	PLDD Project #12. Waste water treatment plant (WWTP) Ditch and Culvert Improvements	Ditch clearing, culvert inlet inspection	Ensure sediment buildup behind rip rap check dams is removed; Remove boards covering the channel at the downstream end; continue to monitor vegetation overgrowth and debris buildup in the channel.

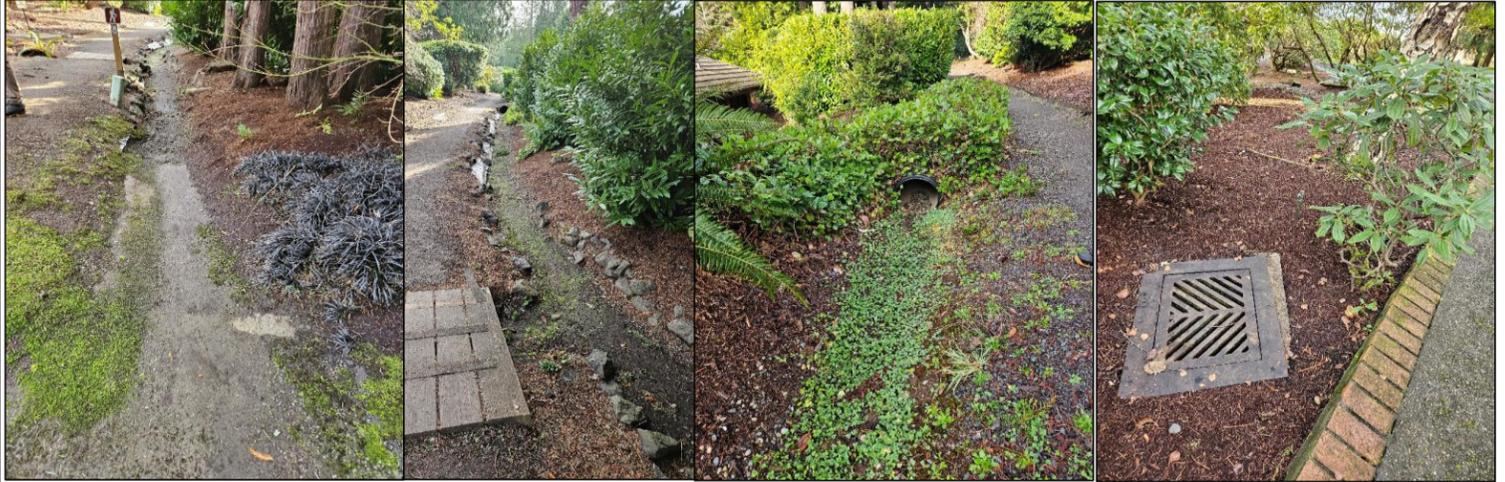
14	990600164	LMC	Common area South end of Libby Court	<u>Open rock lined ditch with check dams that leads to a 36" pipe to a catchbasin and CMP culvert under Montgomery Lane, then into a new CB and 36" 32" HDPE pipe to the marine outfall.</u>	Vegetation maintenance	Russ indicated roots had to be cleaned out of the 18" pipe due to a nearby large tree. Site looked clean; Continue to cleanout culvert, monitor vegetation overgrowth and debris buildup in the channel.

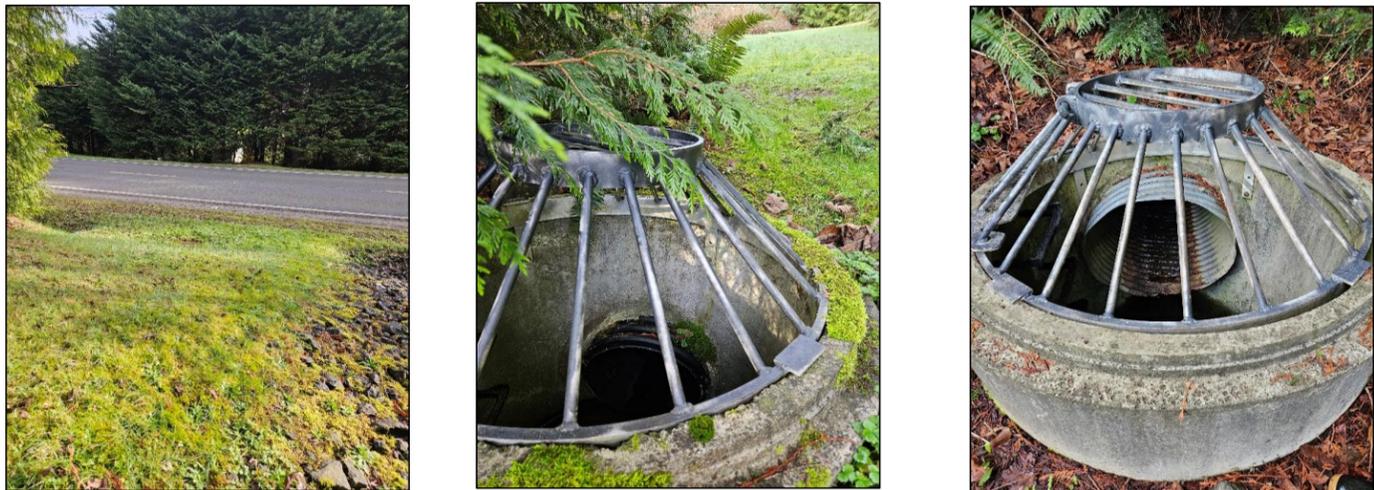
15	990603236	LMC	West of Oak Bay Road and Baldwin Lane intersection	PLDD Projects #5 & 15. <u>Upper Baldwin Drainage Improvement.</u> <u>990603236 covers a wide area. Only one recorded easment #589305.</u>	Clean/Inspect	Area was clean; Continue to monitor manholes for debris/sediment buildup.

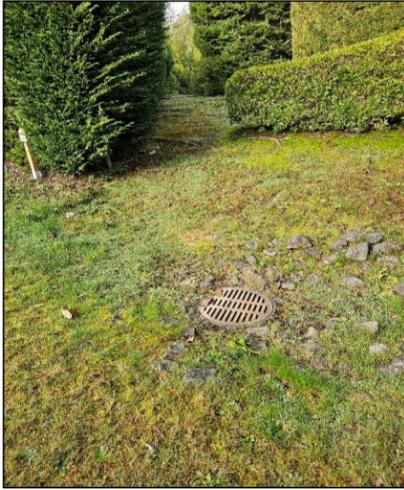
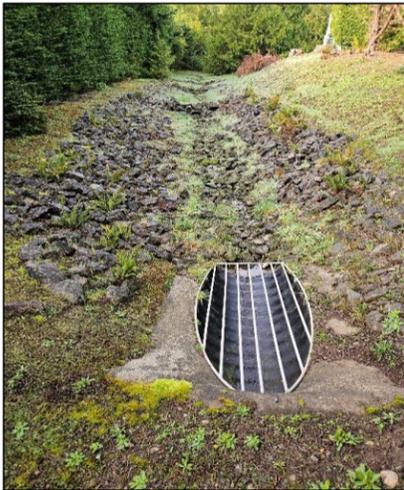
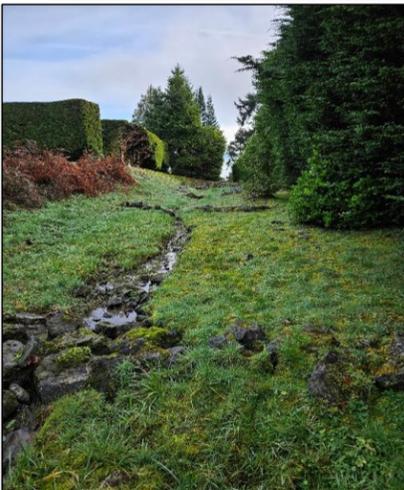
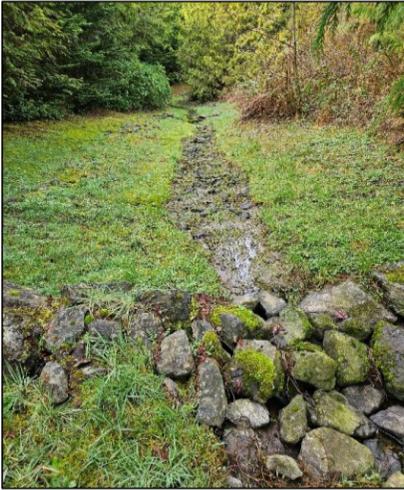
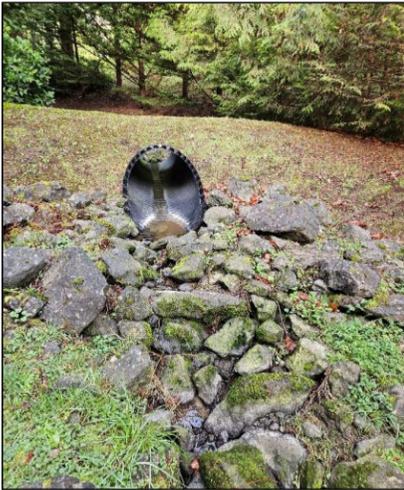
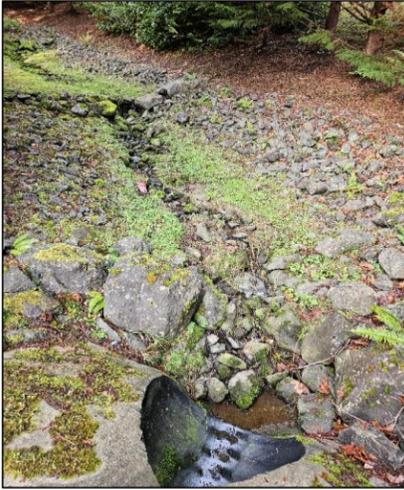
Area #	Parcel Number	Owner	Area Description	Facility Description, Documents, Photos	Maintenance Activities	Inspection Comments	Photos
16	990600164	LMC	Oak Bay Road to Montgomery Lane south of Baldwin	PLDD Project #4. Incised Ditch – Oak Bay Road to Montgomery (Oak Bay Road Phase II)	Vegetation maintenance	Channel and culverts looked very clean; Continue to cleanout culverts out, monitor vegetation overgrowth and debris buildup in the channel.

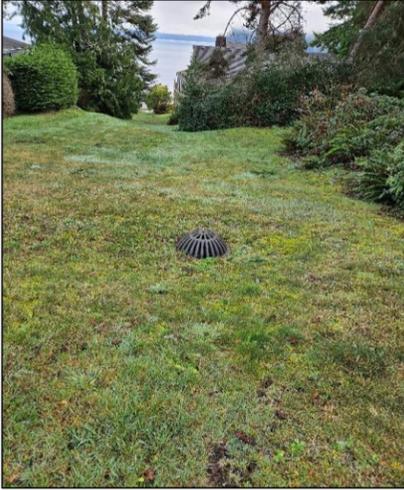
17	990600164	LMC	Montgomery Lane north of Libby Ct to beach	PLDD Project #3. Libby Court Outfall	Inspect and remove any sediment from catch basin.	Outfall was not inspected (need low tide) so recommend inspecting this year; Continue to monitor vegetation overgrowth near beehive catch basin at the upstream end.

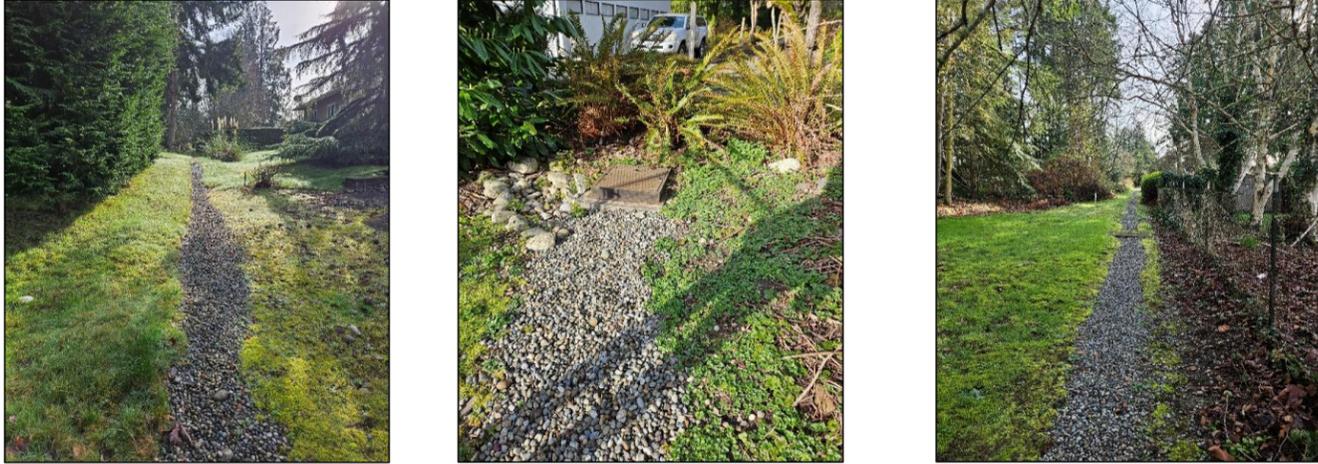
Area #	Parcel Number	Owner	Area Description	Facility Description, Documents, Photos	Maintenance Activities	Inspection Comments	Photos
18	990603236	LMC	Area at the back of lots between Pioneer Drive West and McCurdy Lane	PLDD Project #10. McCurdy Lane Cutoff Trench drain with closed catch basins and a cleanout; Access via concrete driveway at 22 MCCURDY LN. 12-29-22:	Inspect/clear vegetation around drainage area	Area was clean; No water visible; Continue to keep vegetation clear of the area.

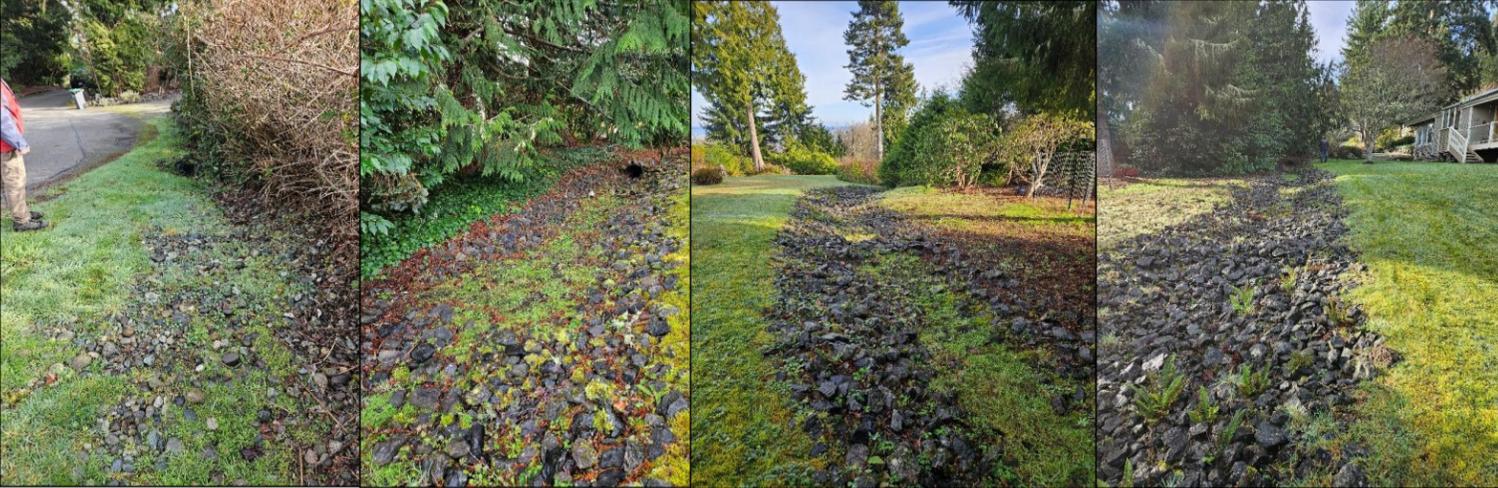
19	990603236	LMC	Northeast end Foster Lane cul-de-sac. G & O Project 06413.05, March 2007.	PLDD Project #8. Foster Lane Drainage Improvement	Pipe inlet cleaning, check rock lined ditch and clear as necessary	Area was clean; County is to maintain upstream cbs; continue to monitor channel for debris/sediment buildup and vegetation overgrowth.

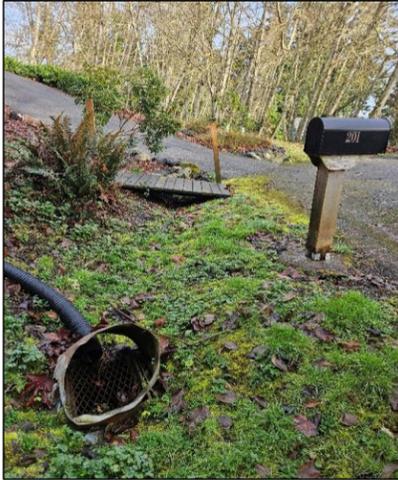
20	990900019	LMC	East side of Montgomery Court cul-de-sac	North Montgomery Court Outfall	Inlet Inspect/clean	Russ checks cb before it joins sewer (picture is of channel upstream); Area appeared clean; Continue to check catch basin for debris.

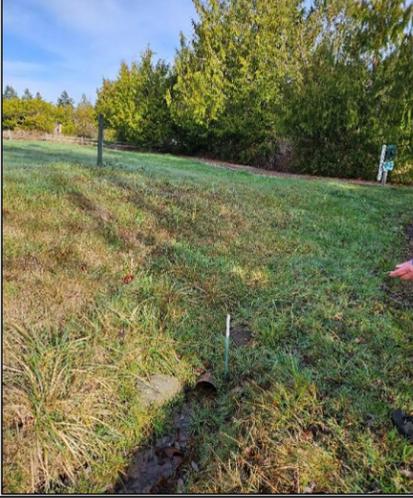
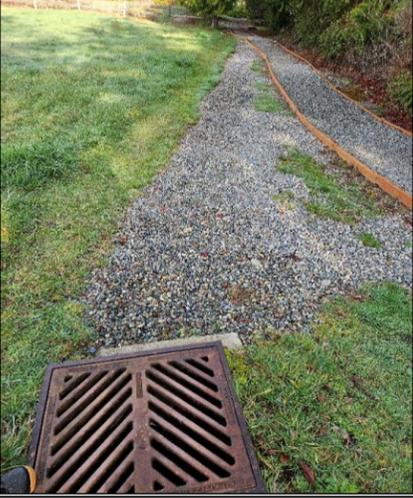
Area #	Parcel Number	Owner	Area Description	Facility Description, Documents, Photos	Maintenance Activities	Inspection Comments	Photos		
21	990603236	LMC	North end Adventurer Lane cul-de-sac	PLDD Project #6. Adventurer Lane Cut-off trench	Inspect & clean	Area was clean; Russ indicated County had to be called to cleanout downstream pipe/ditch area (left pic) because it was so full that it flooded property to the south of the trench drain. Continue to monitor this ditch and ensure vegetation clear of the trench drain.

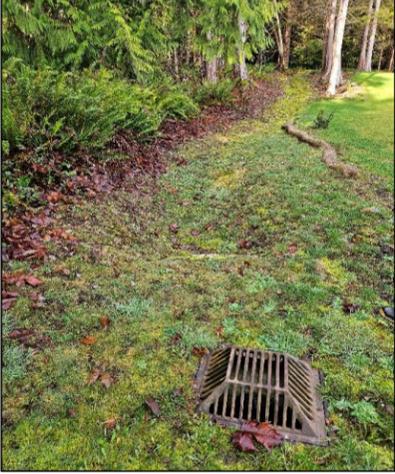
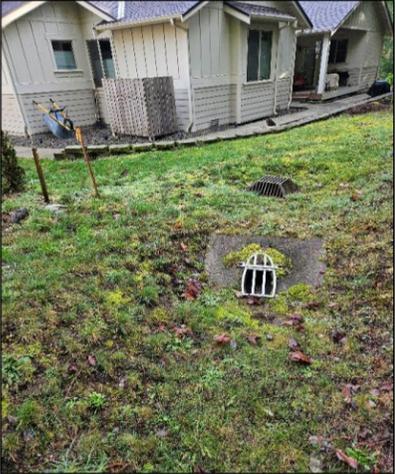
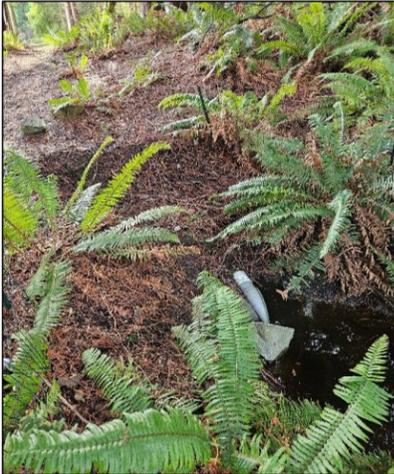
22	990900019	LMC	Between 70 and 120 Montgomery Court	Montgomery Court Outfall	Inspect & clean	Outfall not inspected; Inspect during low tide from beach.			
23	990603236	LMC	South of Trader Lane cul-de-sac	PLDD Project #17. Forester/Trader Lane Improvements, Upstream homeowner installed originally to alleviate water around their house	Inspect & clean	Channel was clean; Russ noted that in the Fall, comes twice/week to clean debris out of 4" pipe at the upstream end near ponded water (see far right pic.); Continue to monitor this area especially in the fall for debris buildup in front of the 4" upstream pipe, the channel and culvert entrance.

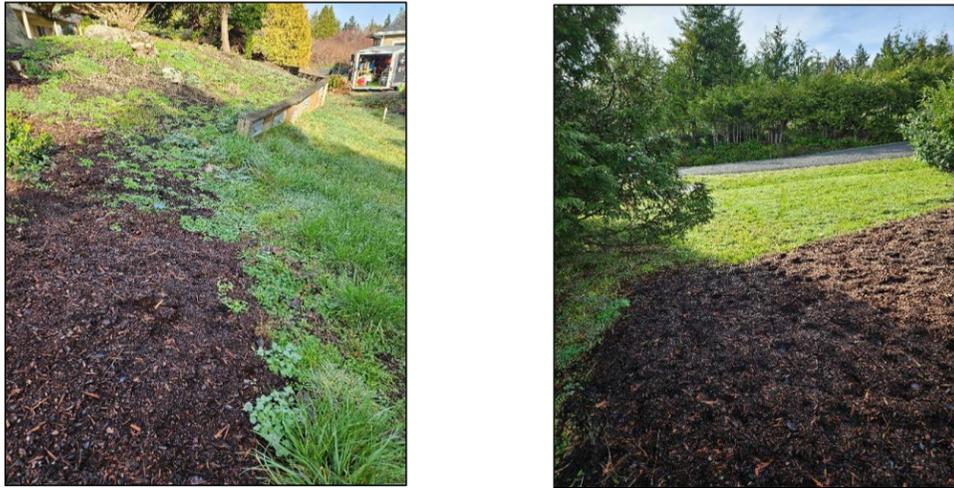
Area #	Parcel Number	Owner	Area Description	Facility Description, Documents, Photos	Maintenance Activities	Inspection Comments	Photos
24	990603236	LMC	Greenbelt north side of Fleet Drive between Pathfinder Lane and Adventurer Lane	French drain but buried and cannot be found now.	None. Included as reference to older inventory	Russ indicated this area was buried and no maintenance is done for the previously installed french drain which discharged to the ditch along Fleet Dr..

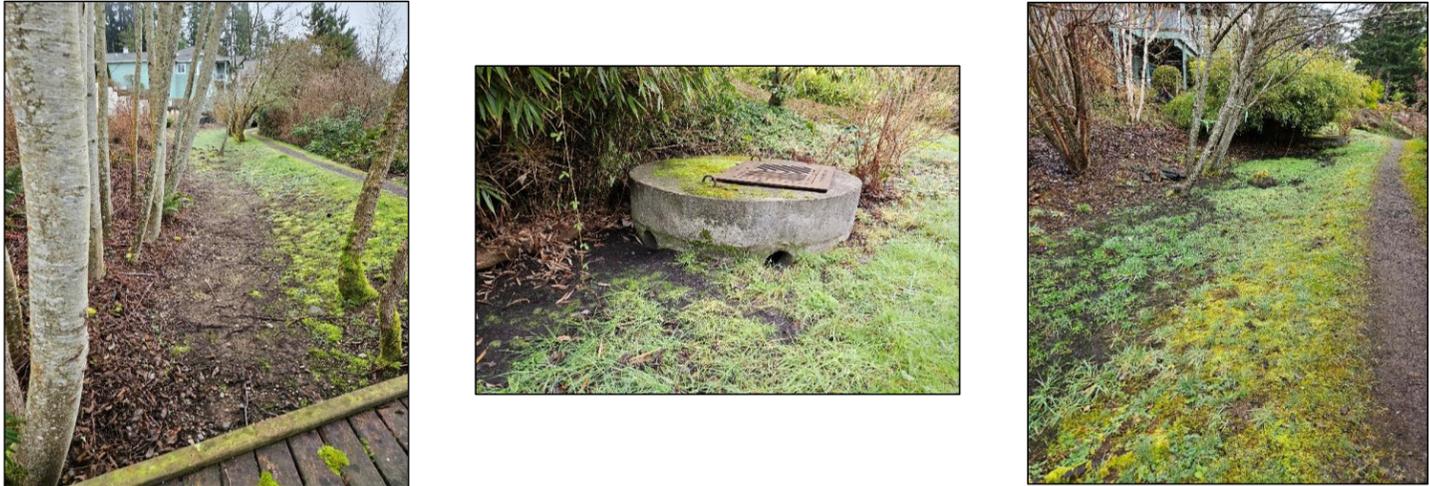
25	990400227	ANITA M & DAVID H WEAKLEY TRUST	East of Condon Lane at intersection of Pope Way and Condon Lane	PLDD Project #9. Pope Way Outfall	Inspect/clean inlet catch basin. Inspect outfall. Potential debris removal at beach outfall.	Outfall not inspected; Inspect during low tide from beach.	
26	968800103	?	Bioswale East of Ebb Tide Ct	Stormwater Drainage Ditch/Swale	Vegetation maintenance/clearing	Adequately clean, continue to monitor sediment in manholes and ensure ditch is clear of overgrown vegetation and excess sediment. Monitor rip rap area at the downstream end.

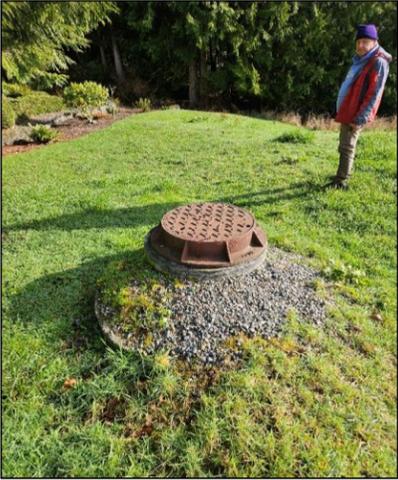
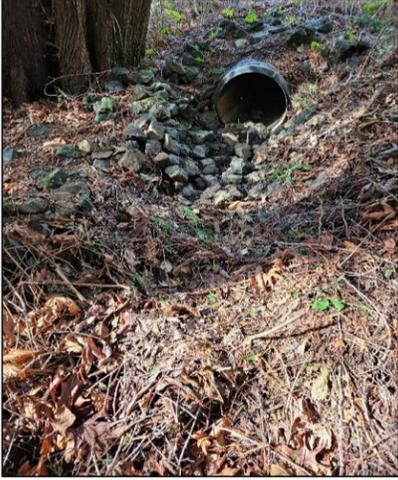
Area #	Parcel Number	Owner	Area Description	Facility Description, Documents, Photos	Maintenance Activities	Inspection Comments	Photos
30	990100200	LMC	South of Rainier Lane and Rainier Court	Rainier Lane Outfall	Inspect & clean	Debris approximately 10' of downstream culvert to be cleared; remaining area looked clean and culvert was clear; Continue to monitor debris buildup in the channel downstream.

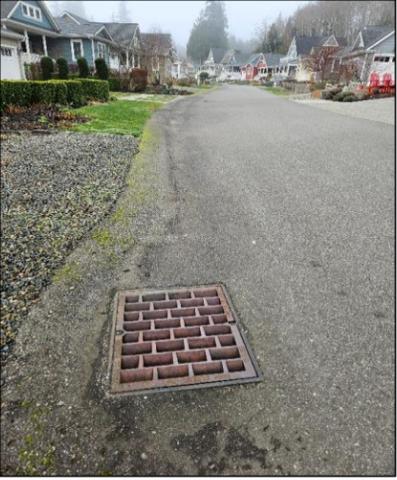
31	968900100	LUDLOW COVE DIVISION 2 HOMEOWNERS ASSOCIATION	Anchor Lane Cottages - CCRs Doc # 487620	Road Catch Basins	Inspect & clean	Appears clean, Russ checks 1-2/yr

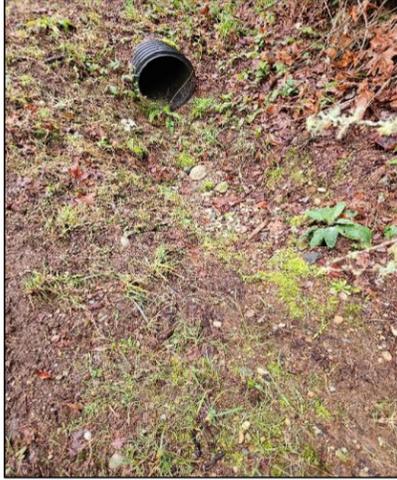
32	990100200	LMC	Greebelt at the end of Wells Ridge Court. See also AFN 406381, Declaration of Covenants and 655233 Updates	18 inch CPEP from the end of the road exiting in the Bioswale at the bottom of the hill.	Inspect, clean as necessary	Area looked clean; continue to cleanout culvert end, monitor vegetation overgrowth and debris buildup in the channel.

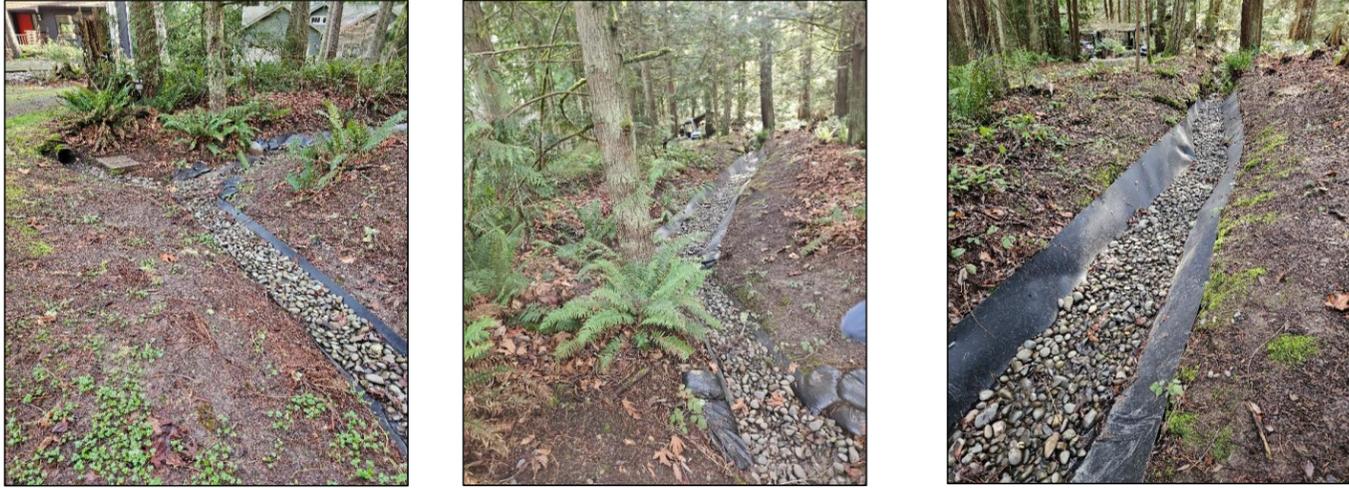
Area #	Parcel Number	Owner	Area Description	Facility Description, Documents, Photos	Maintenance Activities	Inspection Comments	Photos
33	990602105	LMC	Subdivision: 9906 - PORT LUDLOW NO. 2 Assessor's Land Use Code: 7600 - Community Areas - Green Blts - Parks Neighborhood Description: 3333 - PORT LUDLOW #2 AREA 2	Drainage ditch from road, Recently lined (2025?); Russ indicated that property owner to the SE thought the ditch was flooding their house but after lining the ditch, the house appears to continue flooding.	Inspect, clean as necessary	Liner looked in tact and ditch clean; Continue to monitor the integrity of the liner and ensure debris is clear within the channel.

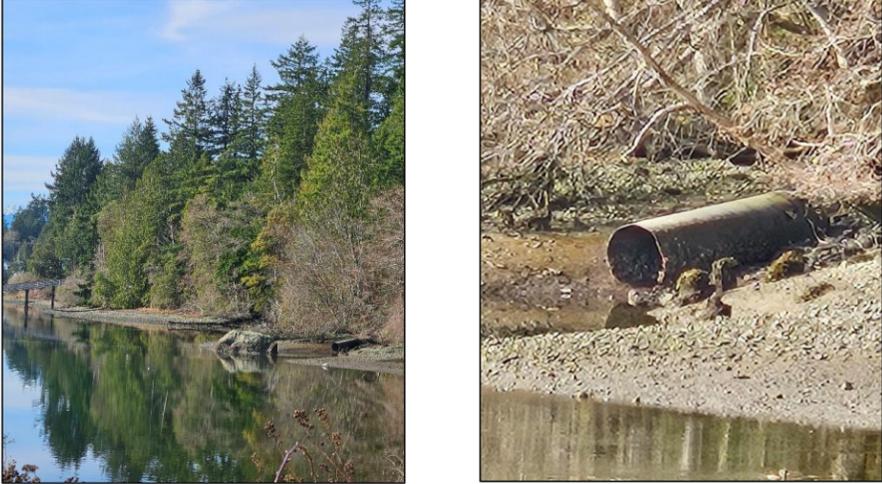
34	9686000071	?	South of Heron Rd	Outfall Pipe	Ensure outfall exist is clear of debris and pipe integrity is sound	Only viewed from Marina but appears to be in fairly adequate shape; Russ to view from beach
