MEMORANDUM

SUBJECT: BEACH OUTFALL RECONNAISSANCE ON

MAY 23 AND JULY 13, 2017

PORT LUDLOW DRAINAGE DISTRICT, JEFFERSON COUNTY, WASHINGTON

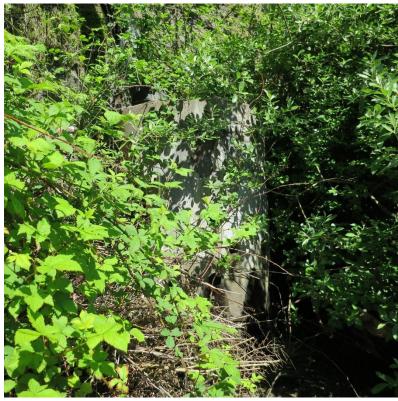
Pope Way Outfall – May 23, 2017

The outfall structure was installed in 2007 and includes a 14-inch-diameter HDPE overbank discharge pipe and a 48-inch-diameter catch basin/diffuser structure on the beach below the bluff. The outfall structure including the overbank pipe is in good condition. The outfall structure is surrounded by dense vegetation and driftwood which does not impact the function of the outfall. The amount of vegetation around the outfall has increased since the last beach walk in 2013. The outfall structure does not appear to need debris removal at this time.

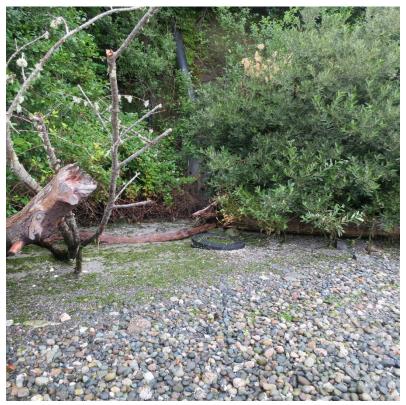
Pope Way Outfall – July 13, 2017 (outfall structure behind driftwood and vegetation)

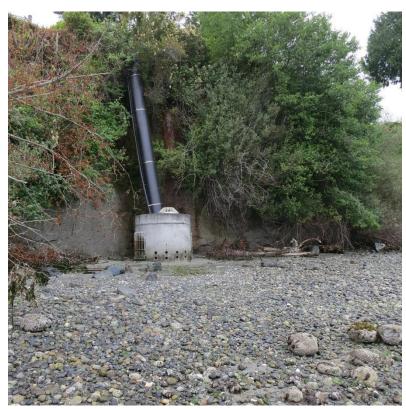
Libby Court Outfall – July 13, 2017

The Libby Court Outfall structure was constructed in 2004. The structure consists of a 32-inch-diameter HDPE overbank discharge pipe and a 60-inch-diameter concrete catch basin/diffuser structure on the beach adjacent to the bluff. The outfall structure including overbank pipe is in good condition. The condition of the beach at the base of the structure has not changed significantly since 2013. The structure does not need cleaning at this time. The bank immediately behind the overbank pipe and outfall structure does not appear to have changed significantly since 2013. The fence at the top of the bank that was installed at the time the outfall was constructed appears to be stable, with no significant change in alignment since 2013.

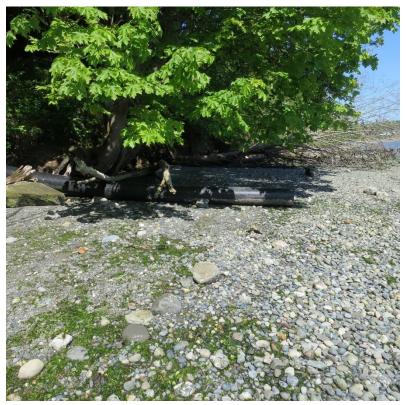
Montgomery Court Outfall – May 23, 2017 (between 70 and 120 Montgomery Court)

This 18-inch-diameter HDPE outfall was not previously known to the District. The LMC does not have any information regarding the culvert. It appears that flow from Basin E1 (northeast end of Jackson Lane) and Oak Bay Road is conveyed between 81 and 101 Montgomery Court, and is discharged along with flow from Basin E2 (Montgomery Court north from Montgomery Lane) to a catch basin in front of 81 Montgomery Court then into the outfall. The culvert pipe appears to have been installed below grade on the LMC parcel. The condition of the pipe at the outfall is excellent. There is no indication of erosion or potential for damage to the outfall at the beach. The beach walk on May 23 terminated at this outfall since we thought this was the outfall from the north end of Montgomery Court.

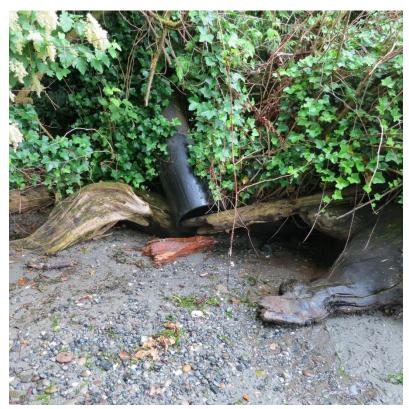
Montgomery Court Outfall – July 13, 2017 (between 192 and 200 Montgomery Court)

This 18-inch-diameter HDPE outfall collects drainage from Basin C2 in the north portion of the District (gully between Jackson Lane and Foster Lane, Oak Bay Road, and the north end of Montgomery Court). This culvert was installed by homeowners on an LMC parcel. The outfall was designed by Dick Reagan, P.E. The outfall daylights at the top of the bank between 192 and 200 Montgomery Court in a thickly wooded area and appears to continue above grade to the beach. The condition of the pipe at the outfall is excellent. There is no indication of erosion or potential for damage to the outfall at the beach.
