## MEMORANDUM

TO: COMMISSIONERS  
FROM: NANCY LOCKETT, P.E.  
DATE: MAY 6, 2021  
SUBJECT: BEACH OUTFALL RECONNAISSANCE ON  
APRIL 1, 2021  
PORT LUDLOW DRAINAGE DISTRICT,  
JEFFERSON COUNTY, WASHINGTON  
G&O #21429.00

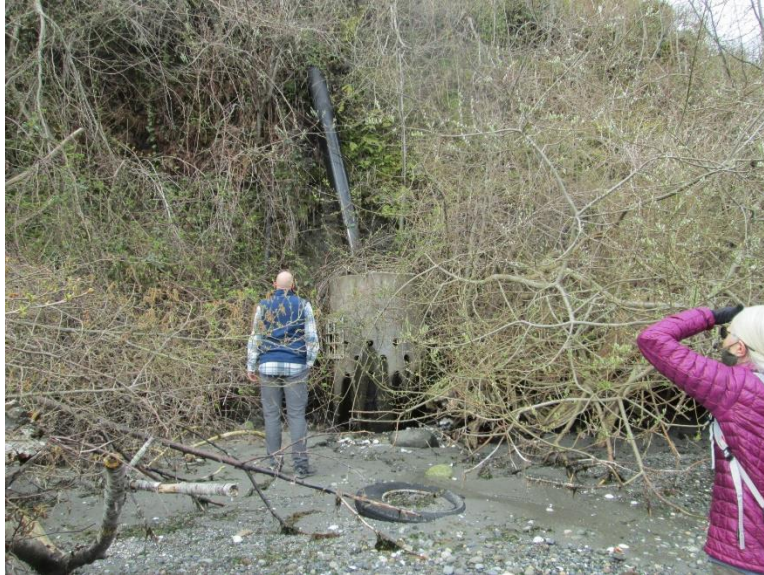
The outfall structure was installed in 2007 and includes a 14-inch diameter HDPE overbank discharge pipe and a 48-inch diameter catch basin/diffuser structure on the beach below the bluff. The outfall structure including the overbank pipe is in good condition. The outfall structure is surrounded by dense vegetation and driftwood which does not impact the function of the outfall. The amount of vegetation around the outfall does not appear have changed appreciably since the last inspection in 2017. The outfall structure does not appear to need debris removal at this time.

**Pope Way Outfall – April 1, 2021**

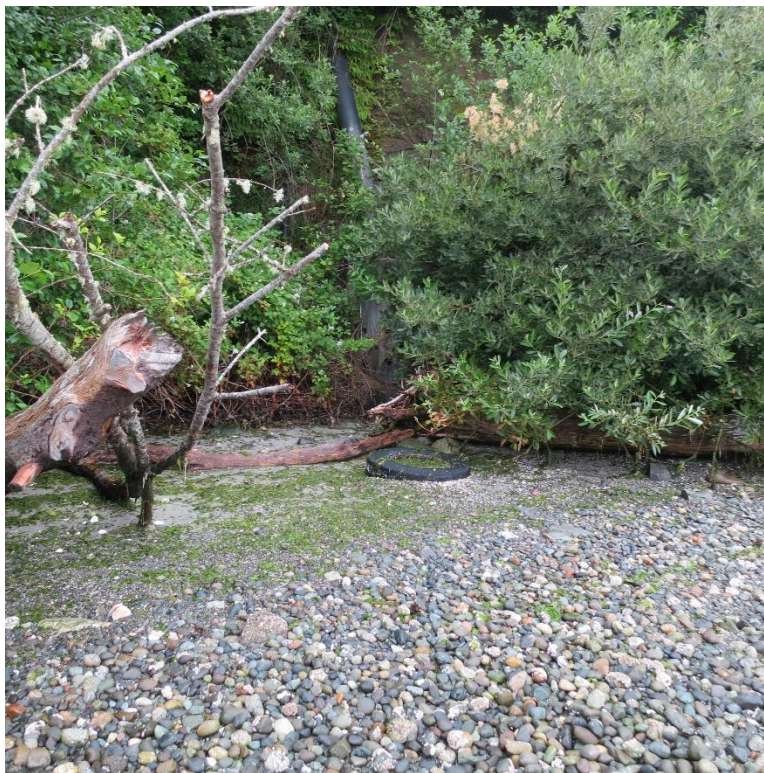
**Pope Way Outfall – July 13, 2017  
(Outfall Structure Behind Driftwood and Vegetation)**

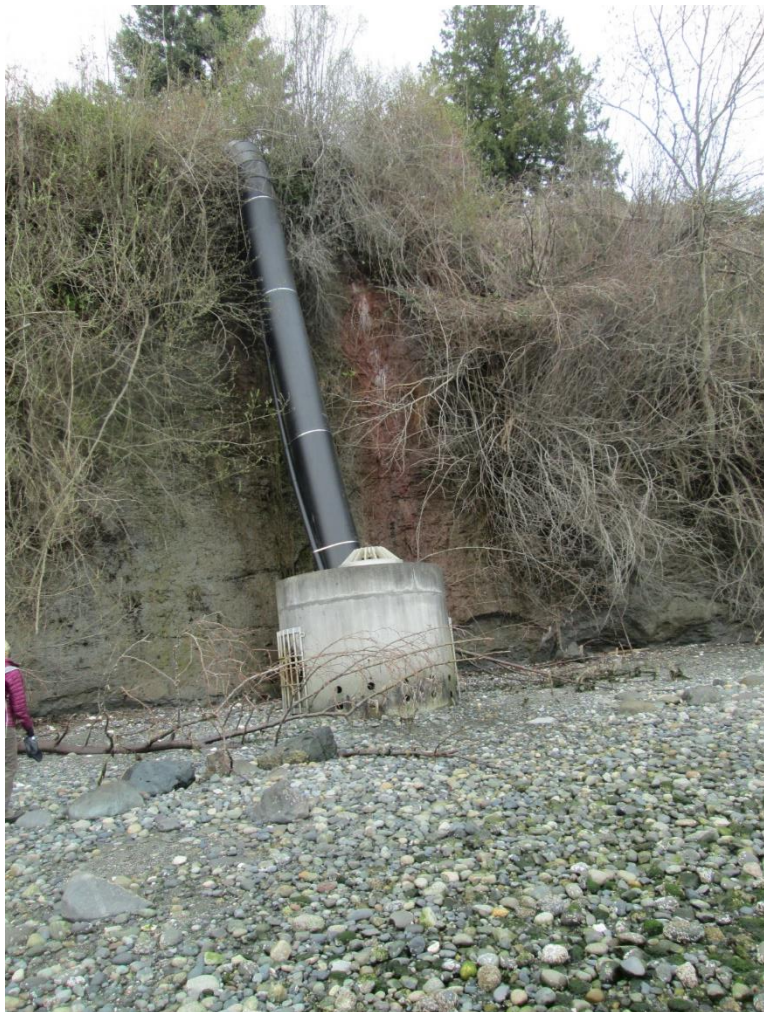
The Libby Court outfall structure was constructed in 2004. The structure consists of a 32-inch diameter HDPE overbank discharge pipe and a 60-inch diameter concrete catch basin/diffuser structure on the beach adjacent to the bluff. The outfall structure including overbank pipe is in good condition. The condition of the beach at the base of the structure has not changed significantly since 2017. The structure does not need cleaning at this time. The bank immediately behind the overbank pipe and outfall structure does not appear to have changed significantly since 2017.

**Libby Court Outfall – April 1, 2021**

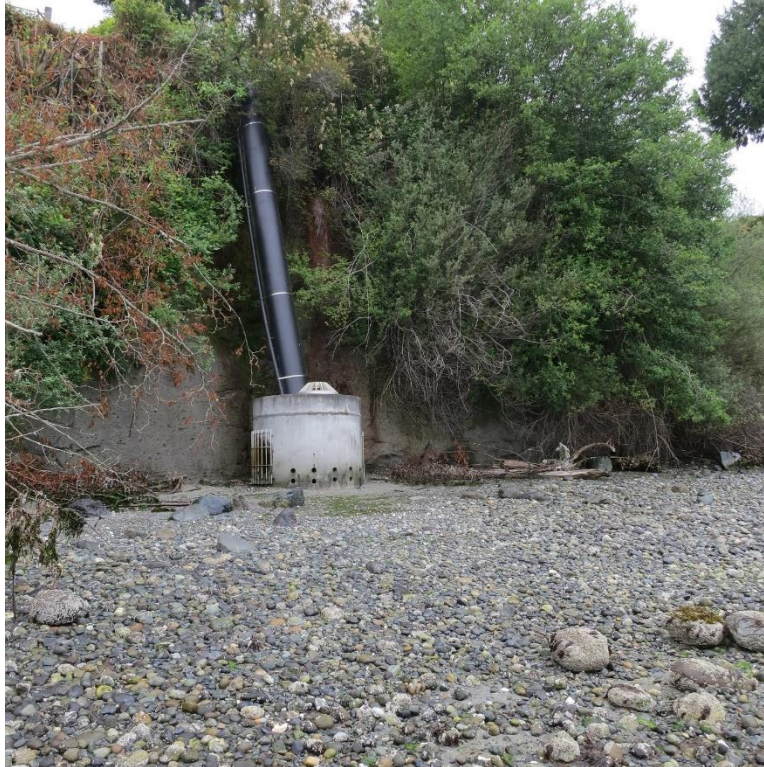
**Libby Court Outfall – July 13, 2017**

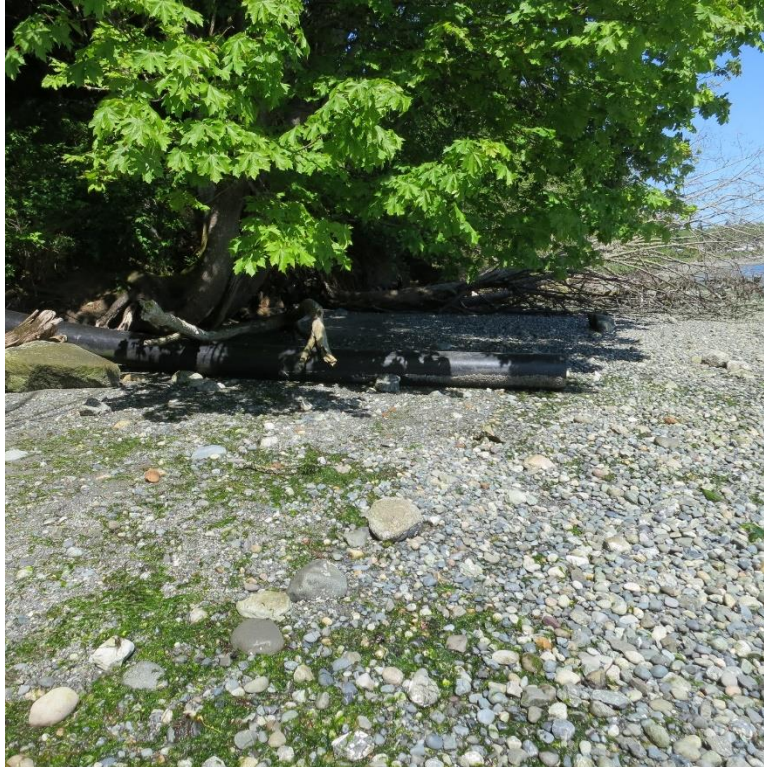
This 18-inch diameter HDPE outfall was identified on the 2017 beach walk. The outfall was not previously known to the District. The Ludlow Maintenance Committee (LMC) does not have any information regarding who installed the culvert or when it was installed. It appears that flow from Basin E1 (northeast end of Jackson Lane) and Oak Bay Road is conveyed between 81 and 101 Montgomery Court and is discharged along with flow from Basin E2 (Montgomery Court north from Montgomery Lane) to a catch basin in front of 81 Montgomery Court then into the outfall. The culvert pipe appears to have been installed below grade on the LMC parcel. The condition of the pipe at the outfall is excellent and has not changed since 2017. There is no indication of erosion or potential for damage to the outfall at the beach.

**Montgomery Court Outfall – May 23, 2017  
(Between 70 and 120 Montgomery Court)**

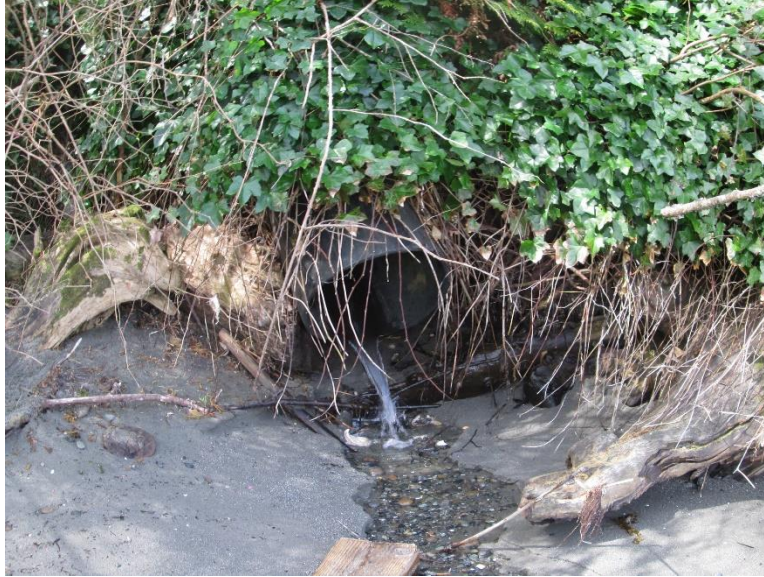
This 18-inch diameter HDPE outfall collects drainage from Basin C2 in the north portion of the District (gully between Jackson and Foster Lanes, Oak Bay Road, and the north end of Montgomery Court). This culvert was installed by homeowners on an LMC parcel. The outfall was designed by Dick Reagan, P.E. The outfall daylights at the top of the bank between 192 and 200 Montgomery Court in a thickly wooded area and appears to continue above grade to the beach. The condition of the pipe at the outfall is excellent. There is no indication of erosion or potential for damage to the outfall at the beach. The condition of the outfall has not changed since 2017.

**Montgomery Court Outfall – April 1, 2021  
(Between 192 and 200 Montgomery Court)**

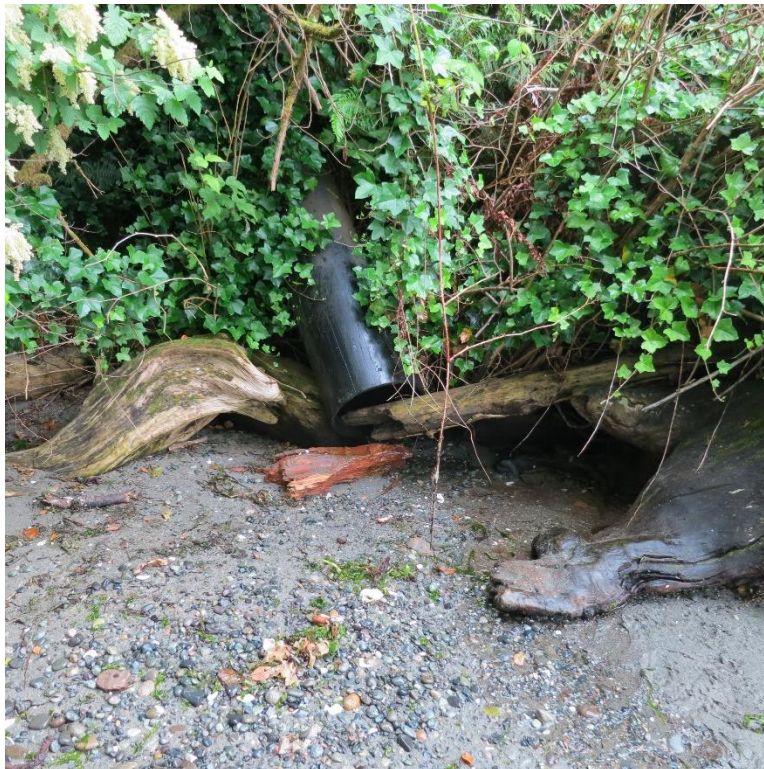
**Montgomery Court Outfall – July 13, 2017  
(Between 192 and 200 Montgomery Court)**

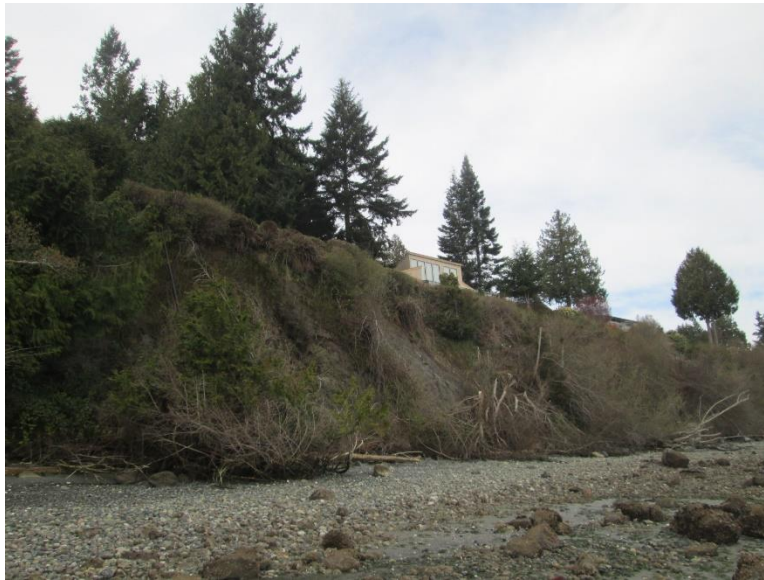
Several locations of severe bluff erosion and extensive tree topping/cutting were identified on the beach as shown in the following pictures.

**Bluff Erosion and Tree Topping**

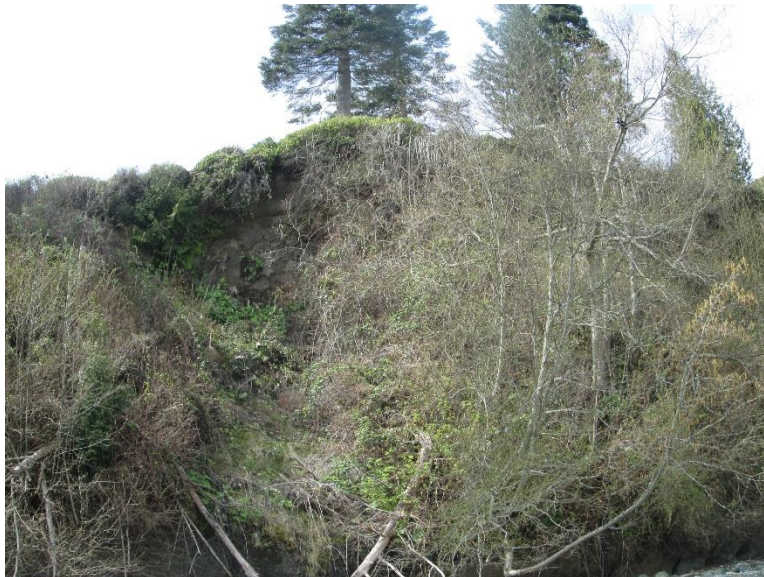
**Bluff Erosion**

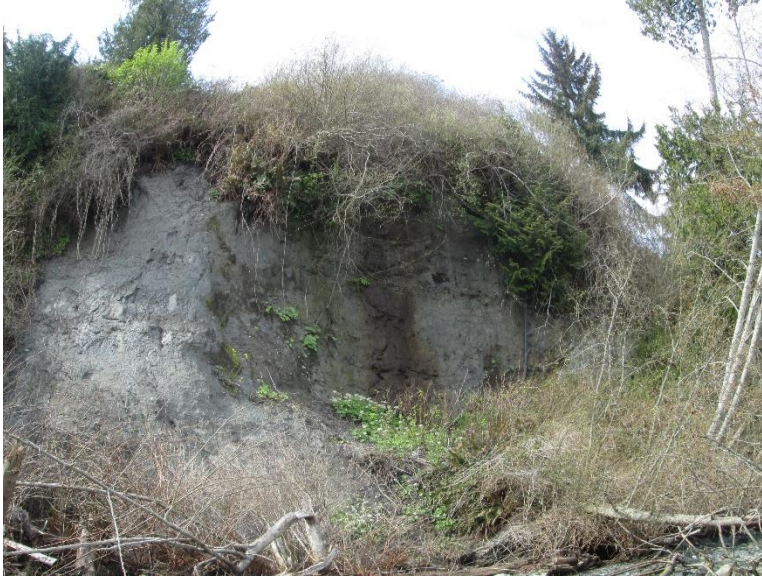
**Bluff Erosion**

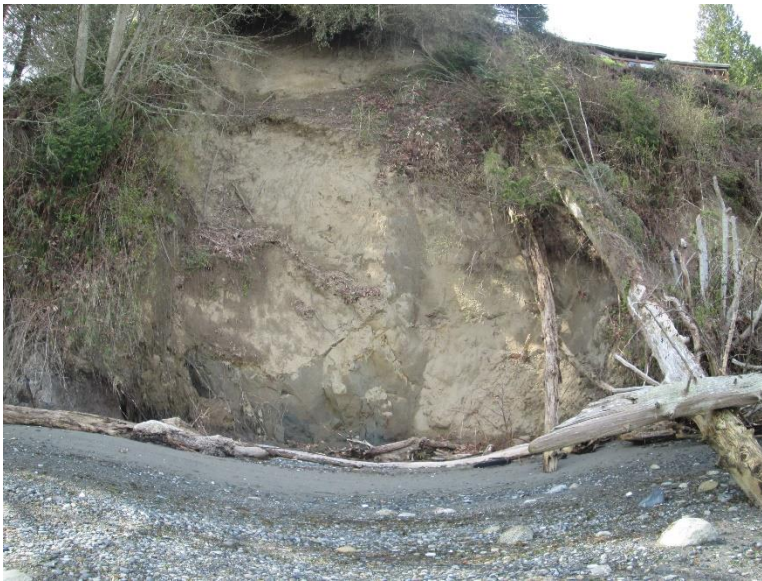
**Bluff Erosion**

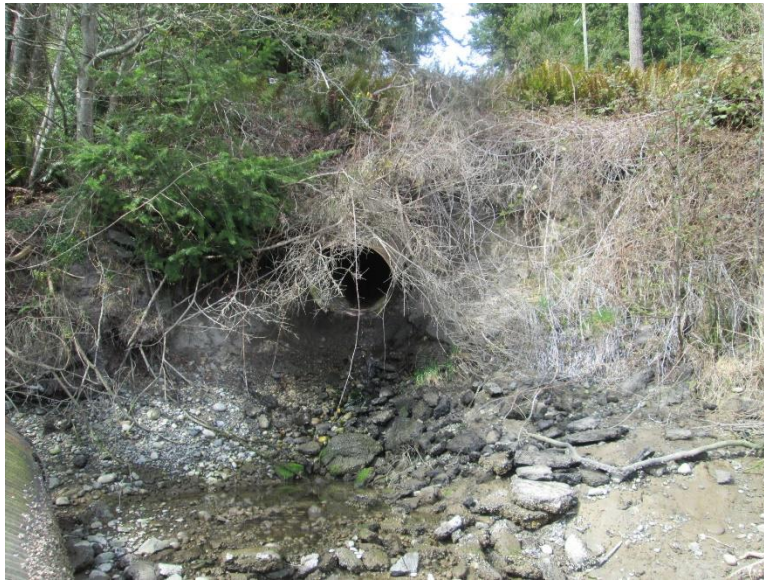
A corrugated metal pipe (36-inch diameter) located on the beach west of the marina discharges runoff from the ditch on the north side of Oak Bay Road. The ditch originates at Oak Bay Road and Walker Way. The date of installation is unknown but most likely was installed prior to development of the plat. The lower approximately 10 feet of the outfall is detached and is laying on the beach. It appears the bottom of the detached pipe was corroded prior to being detached from the outfall. The visible portion of the outfall

also appears to have areas of corrosion on the bottom of the pipe. The soil under the remaining pipe is eroded.

**Oak Bay Outfall – April 1, 2021**

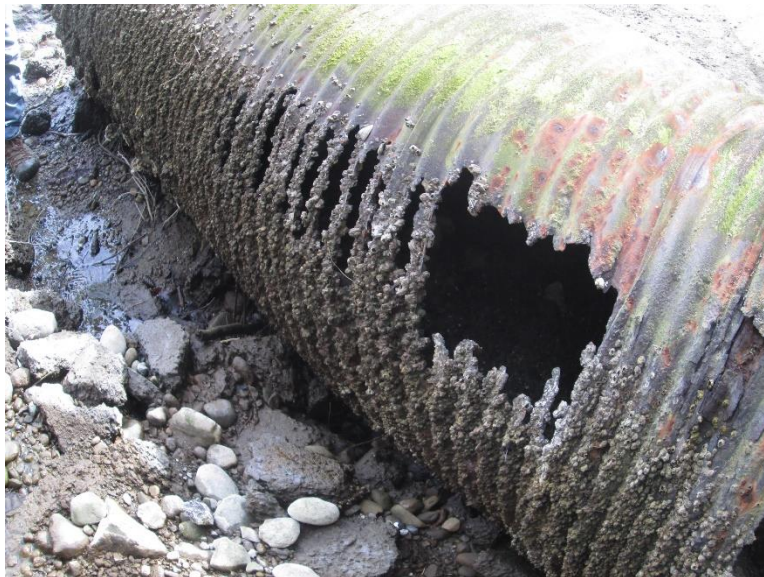
**Detached Portion of Oak Bay Outfall Pipe – April 1, 2021**
