## **MEMORANDUM**

**TO:** PORT LUDLOW DRAINAGE DISTRICT  
COMMISSIONERS  
**FROM:** KERRI SIDEBOTTOM, P.E.  
**DATE:** AUGUST 3, 2023  
**SUBJECT:** BEACH OUTFALL RECONNAISSANCE  
JULY 13, 2023  
PORT LUDLOW DRAINAGE DISTRICT  
JEFFERSON COUNTY, WASHINGTON  
G&O #23429.00

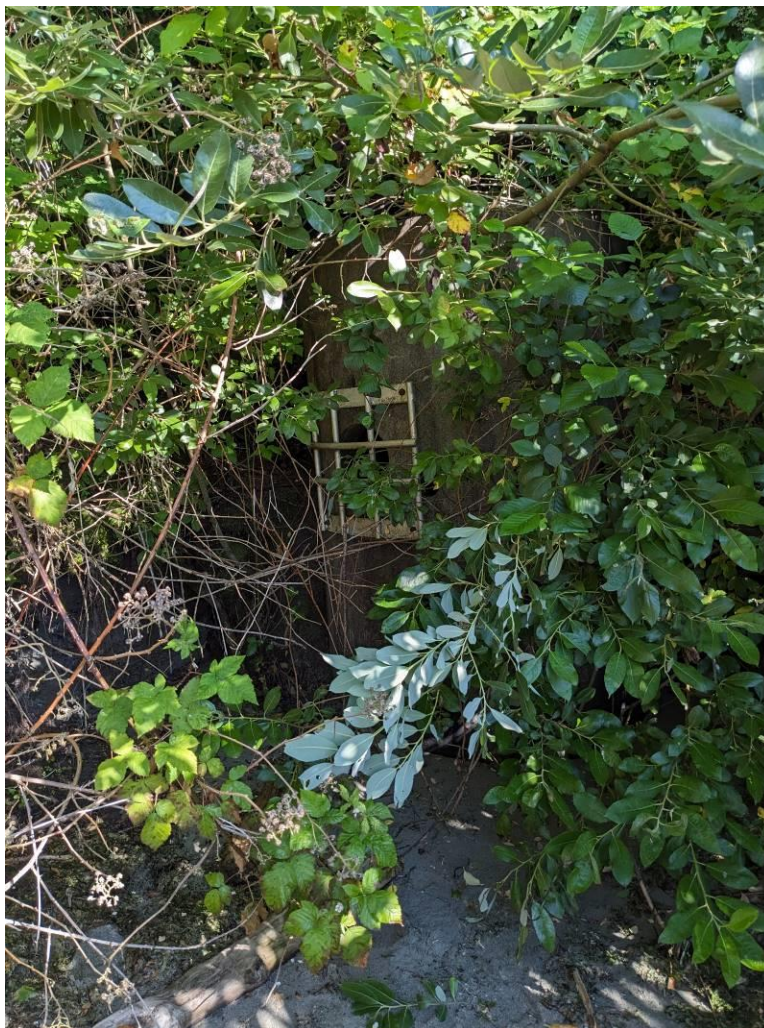
The outfall structure was installed in 2007 and includes a 14-inch diameter HDPE overbank discharge pipe and a 48-inch diameter catch basin/diffuser structure on the beach below the bluff. The outfall structure including the overbank pipe is in good condition. The outfall structure is surrounded by dense vegetation and driftwood, which does not impact the function of the outfall. The amount of vegetation around the outfall does not appear to have notably increased since the last inspection in 2021. The outfall structure was difficult to locate behind an overgrown bush, and vines were observed over the top of and around the structure. It did not appear that any vegetation or roots were intruding into the structure itself or the pipe joints.

The inside of the outfall structure was inspected, and there was no apparent accumulation of debris or other blockages. The outfall structure does not appear to need debris removal

at this time. There was no obvious erosion or channelization on the beach downslope of the outfall structure.

**Pope Way Outfall Structure – July 13, 2023**

The District may consider trimming back some of the vegetation around the structure to make the structure more easily visible for maintenance and inspection in the future. Any vegetation removal should be limited to branches and leaves, so that the slope stability provided by the plant roots is not compromised. Roots and vines may be cleared from the top of the structure to prevent vegetation from intruding into the structure.

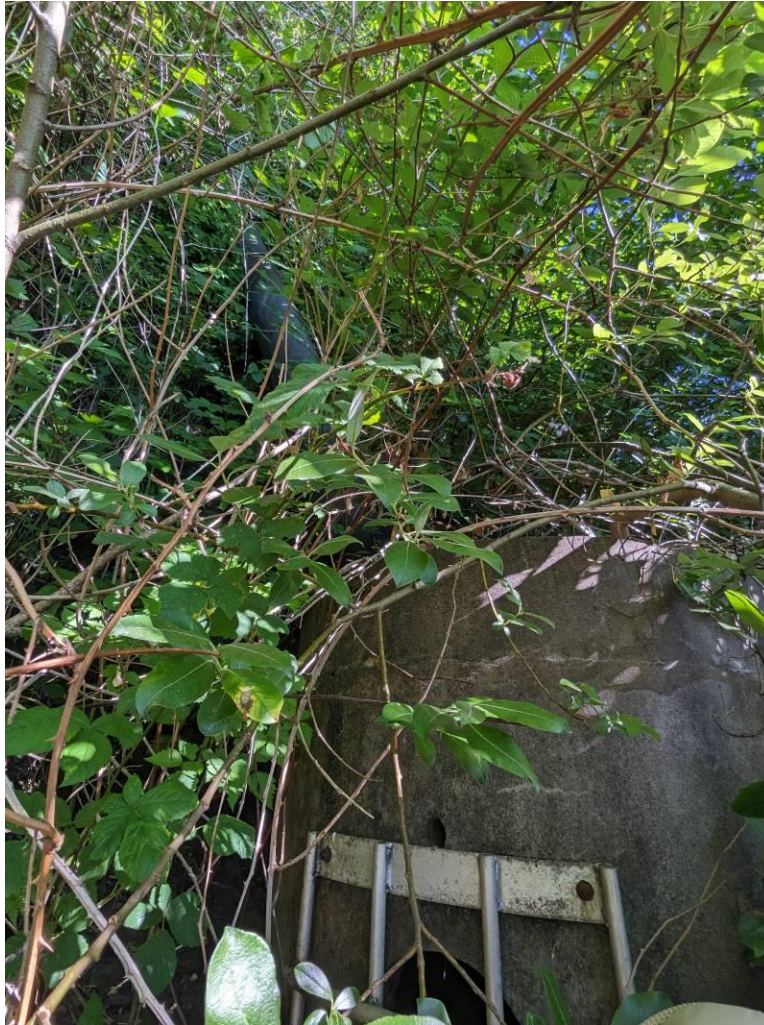
**Pope Way Outfall Structure Inlet Pipe – July 13, 2023**

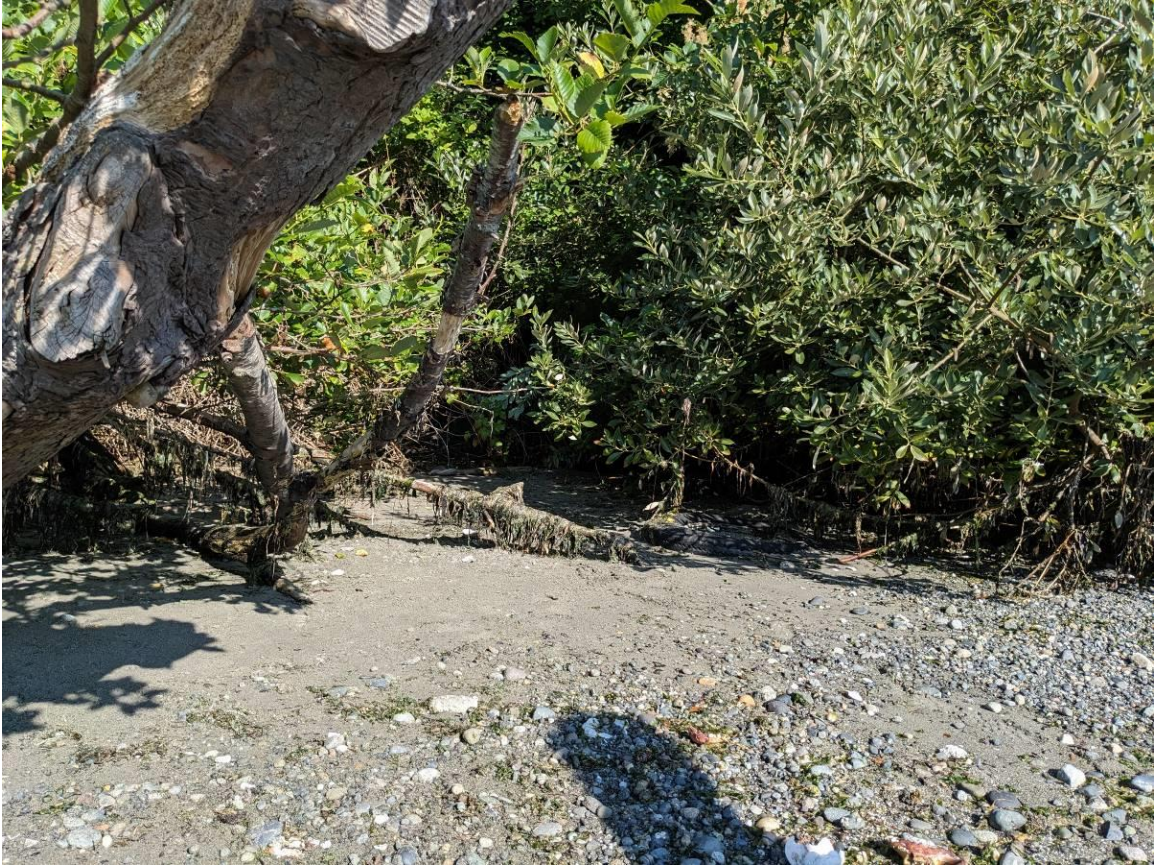
**Pope Way Outfall – July 13, 2023  
(Outfall Structure Behind Driftwood and Vegetation)**

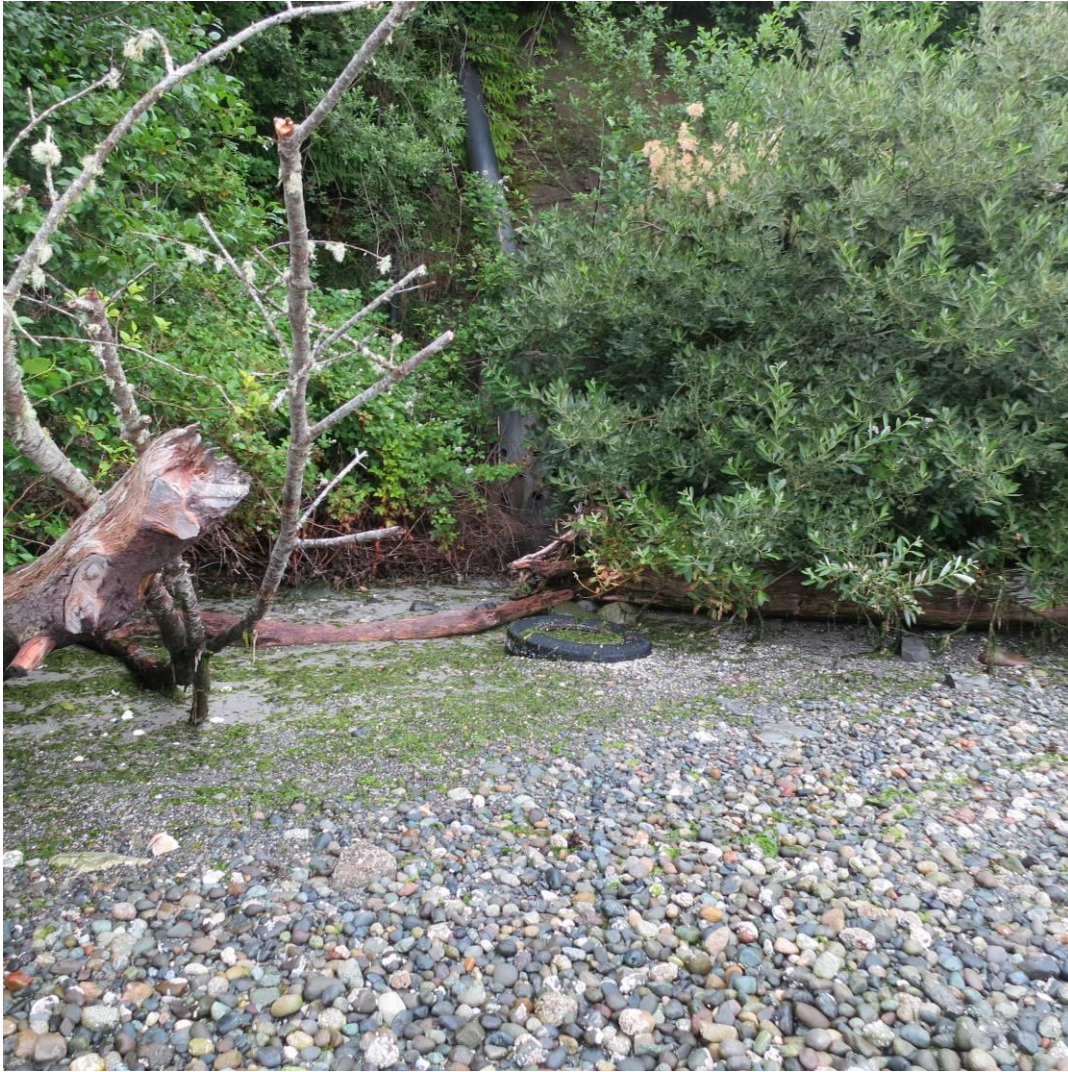
**Pope Way Outfall – July 13, 2017**  
**(Outfall Structure Behind Driftwood and Vegetation)**

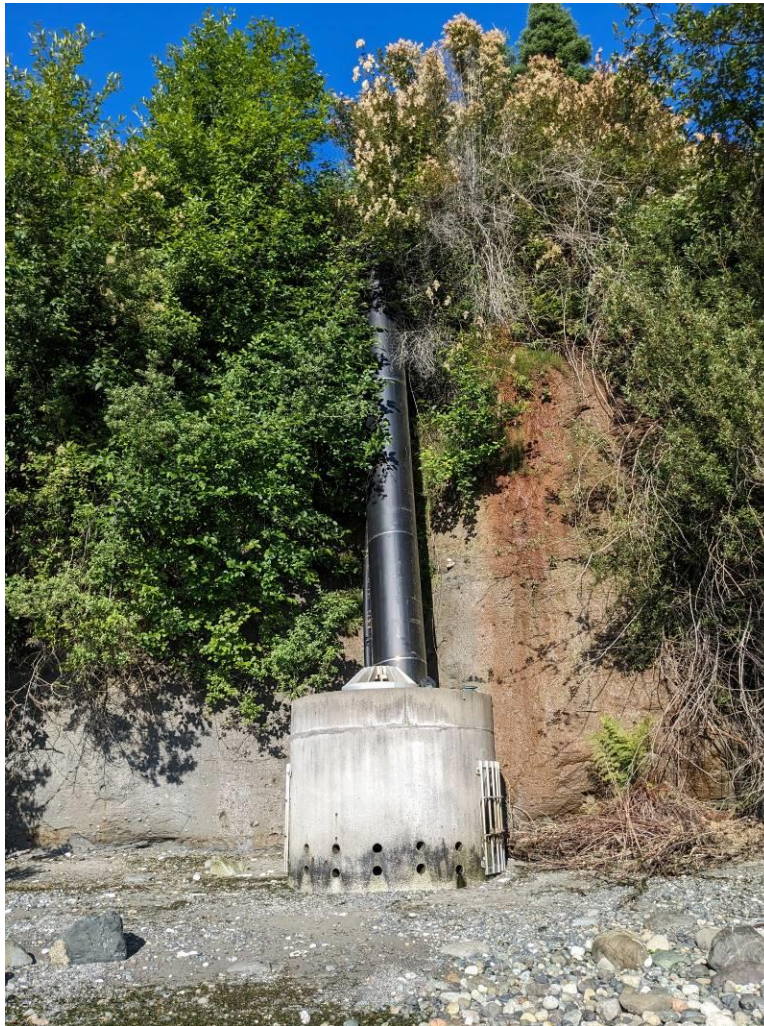
The Libby Court Outfall structure was constructed in 2004. The structure consists of a 32-inch diameter HDPE overbank discharge pipe and a 60-inch diameter concrete catch basin/diffuser structure on the beach adjacent to the bluff. The outfall structure including the overbank pipe is in good condition. The condition of the beach at the base of the structure has not changed significantly since 2017. The interior of the structure was inspected and does not appear to need cleaning at this time, with no accumulated debris

or vegetation. A permanent pool of water was observed within the structure. The bank immediately behind the overbank pipe and outfall structure does not appear to have changed significantly since 2017. There was no obvious erosion or channelization on the beach downslope of the outfall structure.

**Libby Court Outfall – July 13, 2023**

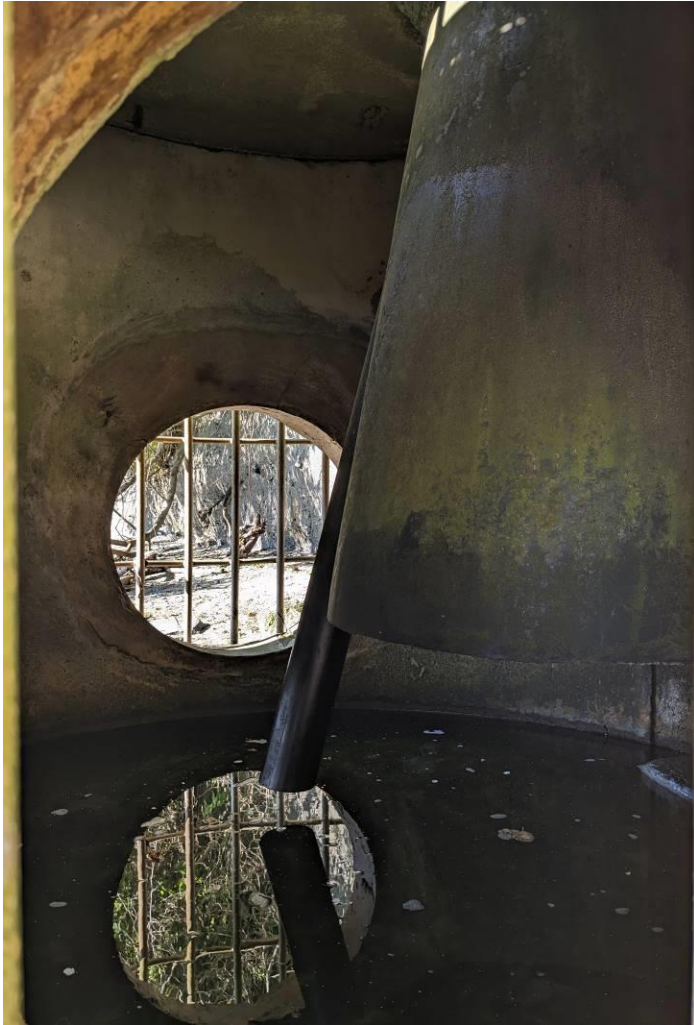
**Libby Court Outfall Interior – July 13, 2023**

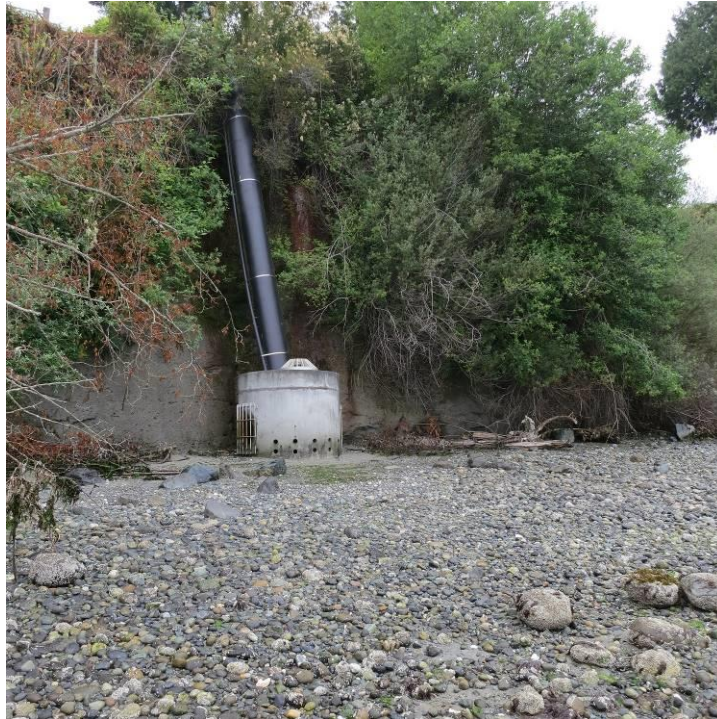
**Libby Court Outfall – July 13, 2017**

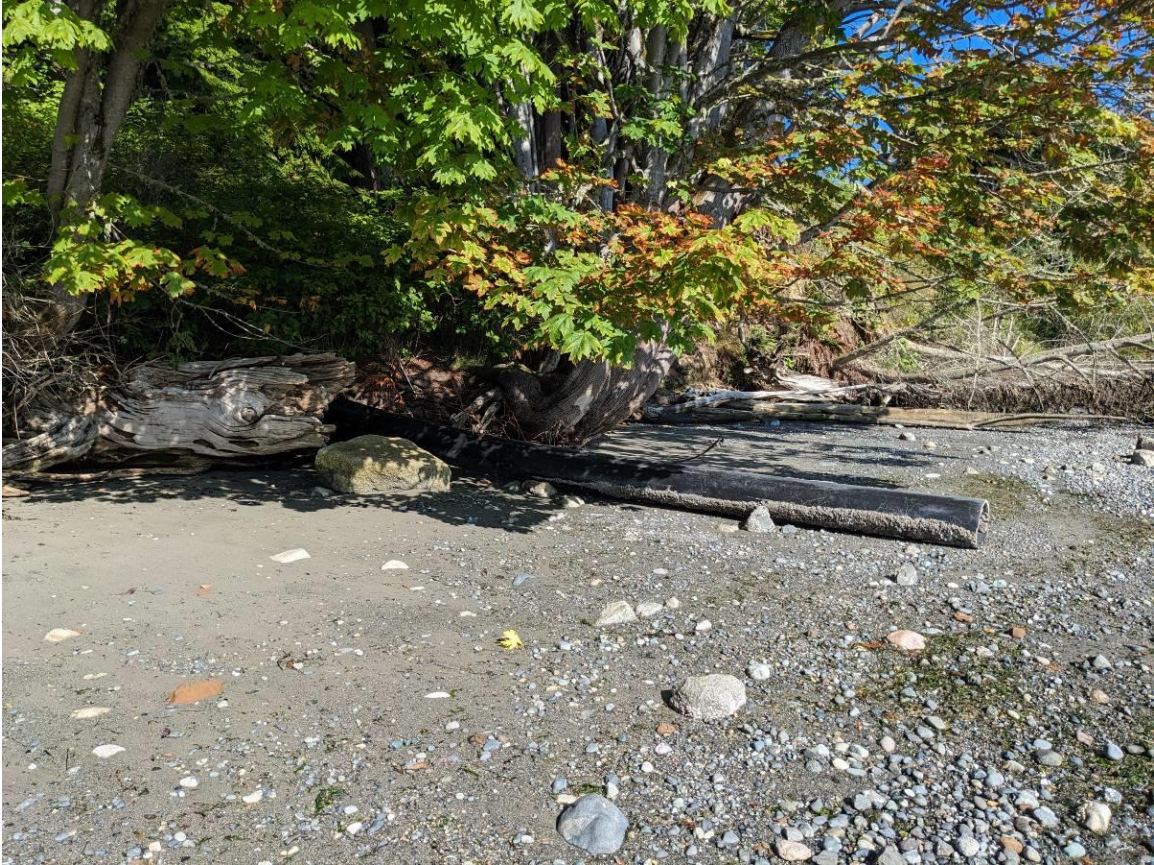
This 18-inch diameter HDPE outfall was identified on the 2017 beach walk. The LMC does not have any information regarding who installed the outfall pipe or when it was installed. It appears that flow from Basin E1 (northeast end of Jackson Lane) and Oak Bay Road is conveyed between 81 and 101 Montgomery Court and is discharged along with flow from basin E2 (Montgomery Court north from Montgomery Lane), to a catch basin in front of 81 Montgomery Court and then into the outfall. The pipe appears to have been installed below grade on the LMC parcel. The condition of the pipe at the outfall is excellent and has not changed since 2017. There is no indication of erosion or potential for damage to the outfall at the beach. The exterior of the lower half of the pipe is covered in barnacles, and a small amount of sand has accumulated at the end of the pipe, presumably due to the tide. These conditions do not compromise the function of the pipe.

**Montgomery Court Outfall (Between 70 and 120 Montgomery Court) –  
July 13, 2023**

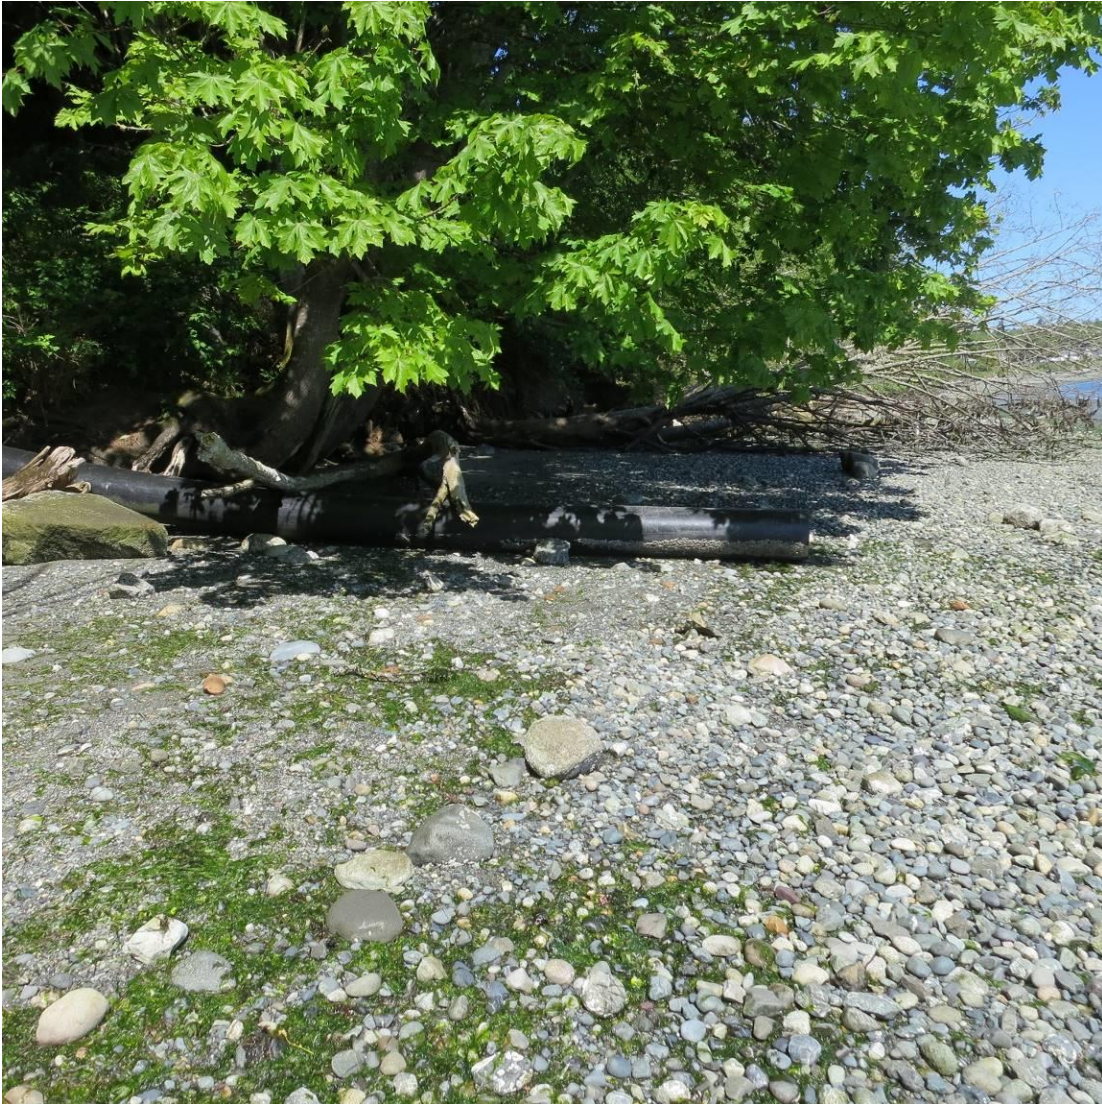
**Montgomery Court Outfall (Between 70 and 120 Montgomery Court) –  
May 23, 2017**

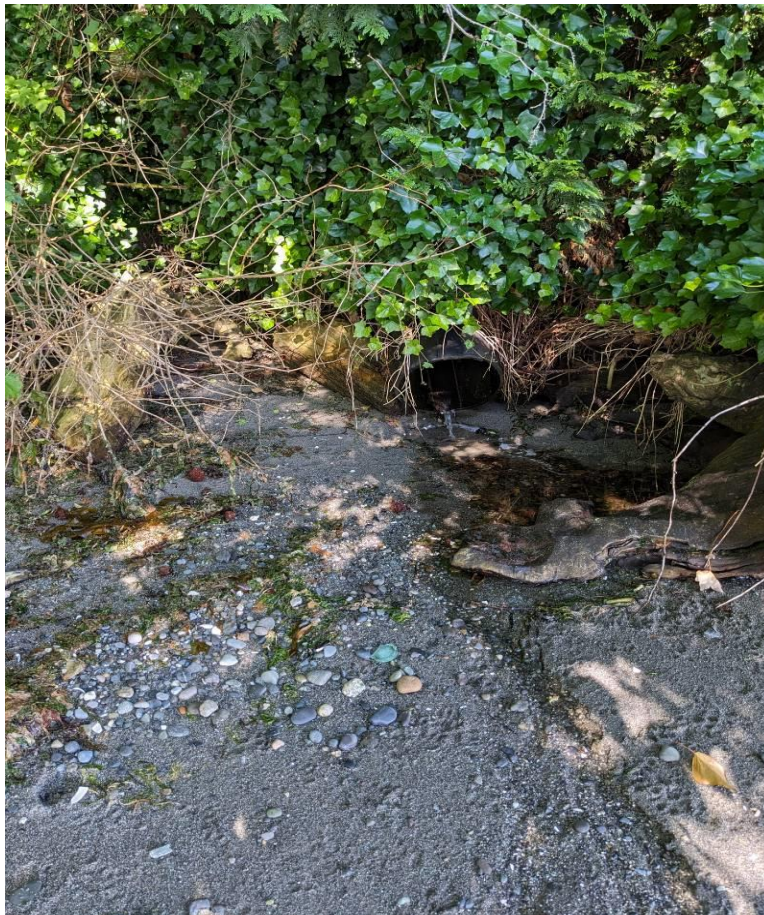
This 18-inch diameter HDPE outfall collects drainage from Basin C2 in the north portion of the District (a gully between Jackson and Foster Lanes, Oak Bay Road, and the north end of Montgomery Court). This culvert was installed by homeowners on an LMC parcel and was designed by Dick Reagan, P.E. The outfall daylights at the top of the bank between 192 and 200 Montgomery Court in a thickly wooded area and appears to continue above grade down to the beach. During the inspection, the pipe was observed to have water flowing out of it, despite a period of dry weather prior to the inspection. The water had created a small channel within the sand at the outlet of the pipe; however, this channel is below the high tide level and does not appear to be causing any damage to the outfall or the beach. The condition of the pipe at the outfall is excellent and the end of the pipe is clear. The condition of the outfall has not changed since 2017.

**Montgomery Court Outfall (Between 192 and 200 Montgomery Court) –  
July 13, 2023**

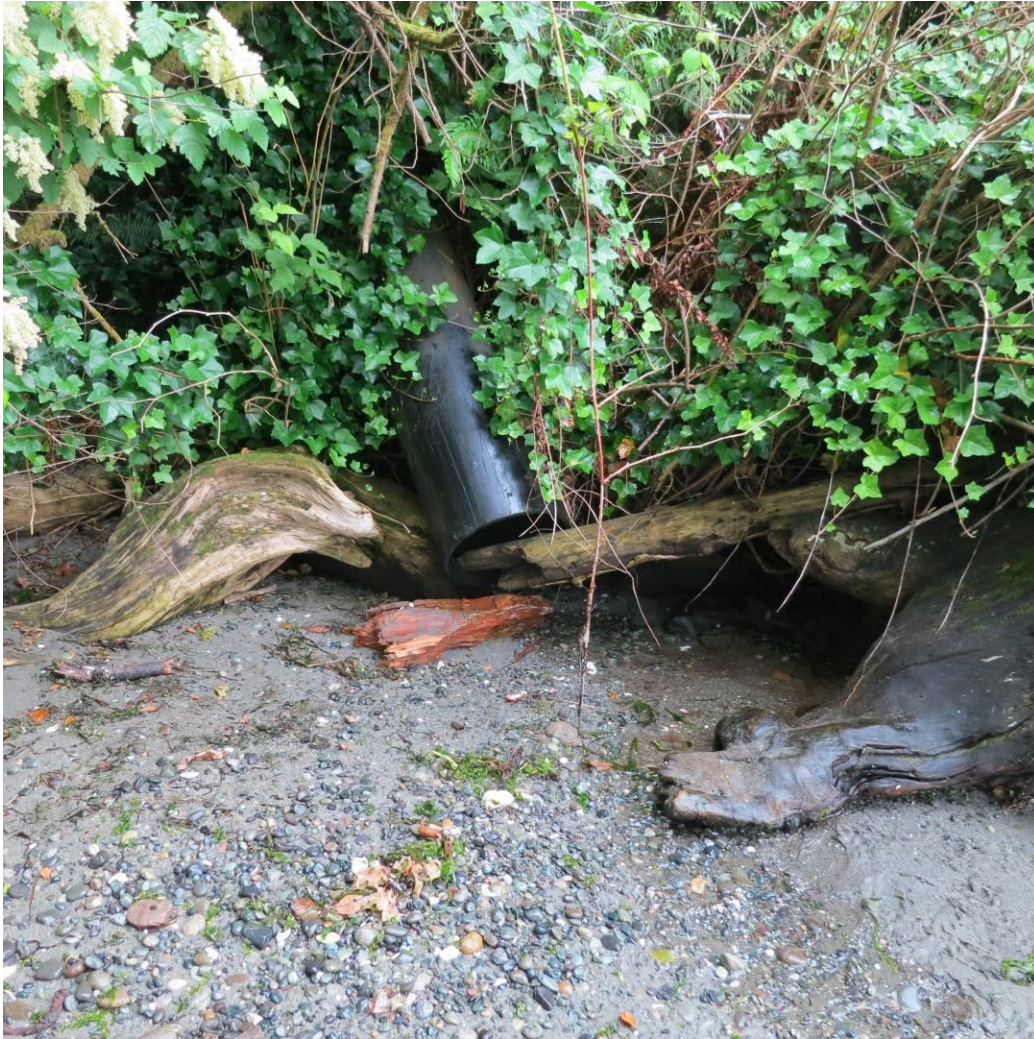
**Montgomery Court Outfall (Between 192 and 200 Montgomery Court) –  
July 13, 2017**

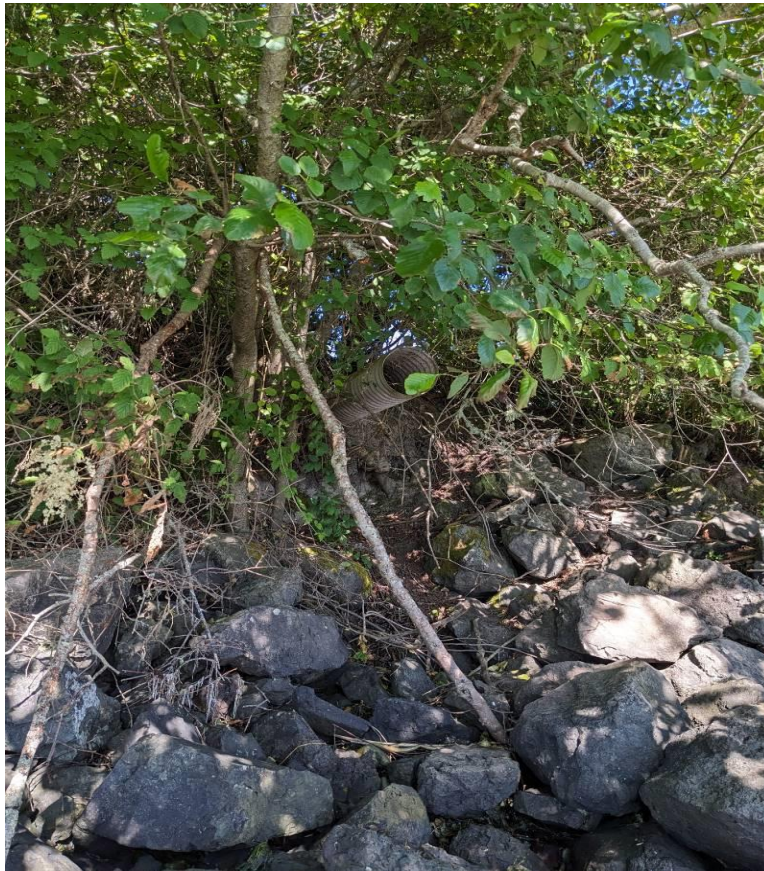
A 12-to 15-inch diameter CMP outfall collects drainage from the wastewater treatment plant site and discharges to the beach over a rocky bank. This outfall pipe appears to be in fair condition and appears to be situated well above the high tide level. No maintenance needs were identified at this time. The District did not originally install this pipe and has not historically maintained it. The District's mapping indicates a 42-inch pipe in the same area as this outfall pipe, but the larger pipe was not found during the inspection.

**Wastewater Treatment Plant Drainage Outfall – July 13, 2023**
