MEMORANDUM

TO: COMMISSIONERS
FROM: NANCY LOCKETT, P.E.
DATE: SEPTEMBER 11, 2017
SUBJECT: BEACH OUTFALL RECONNAISSANCE ON
MAY 23 AND JULY 13, 2017
PORT LUDLOW DRAINAGE DISTRICT,
JEFFERSON COUNTY, WASHINGTON
G&O #17426.00

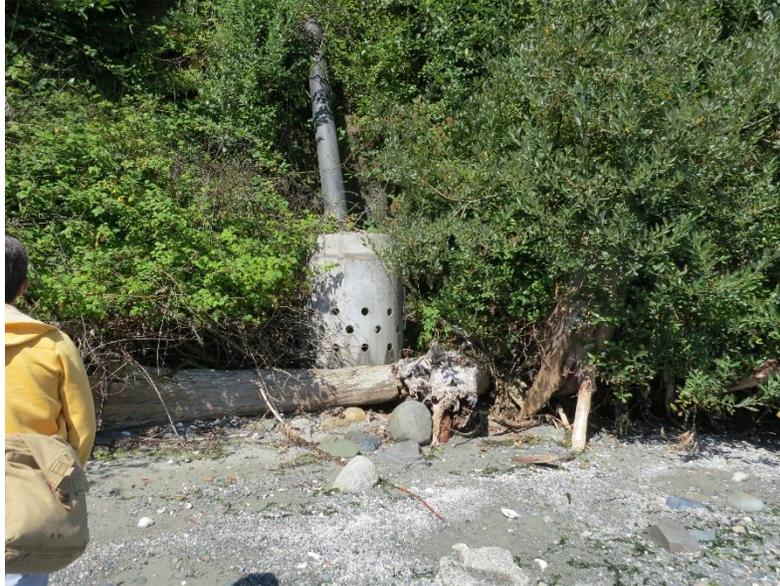
The outfall structure was installed in 2007 and includes a 14-inch-diameter HDPE overbank discharge pipe and a 48-inch-diameter catch basin/diffuser structure on the beach below the bluff. The outfall structure including the overbank pipe is in good condition. The outfall structure is surrounded by dense vegetation and driftwood which does not impact the function of the outfall. The amount of vegetation around the outfall has increased since the last beach walk in 2013. The outfall structure does not appear to need debris removal at this time.

Pope Way Outfall – August 20, 2013

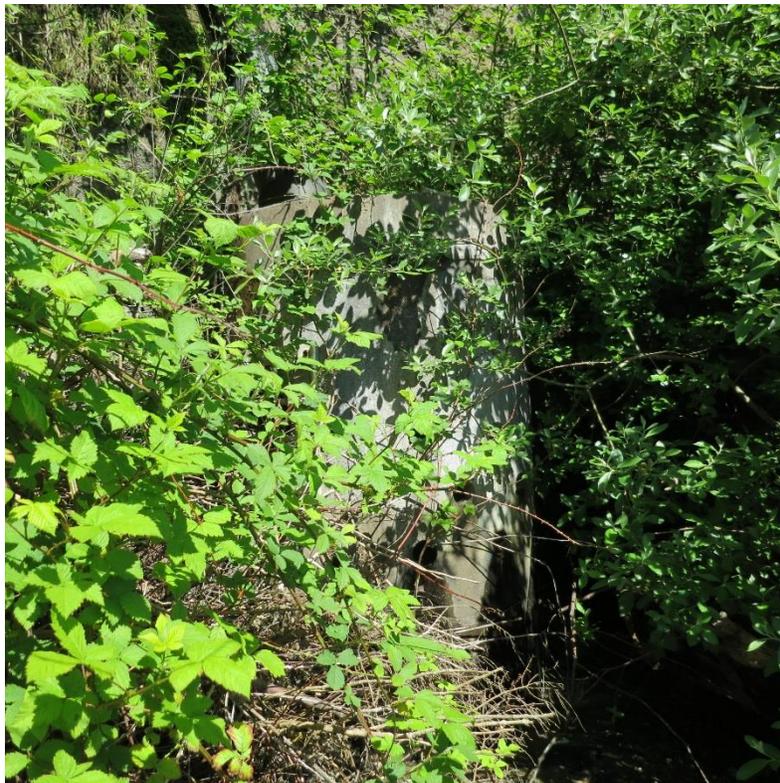
Pope Way Outfall – May 23, 2017

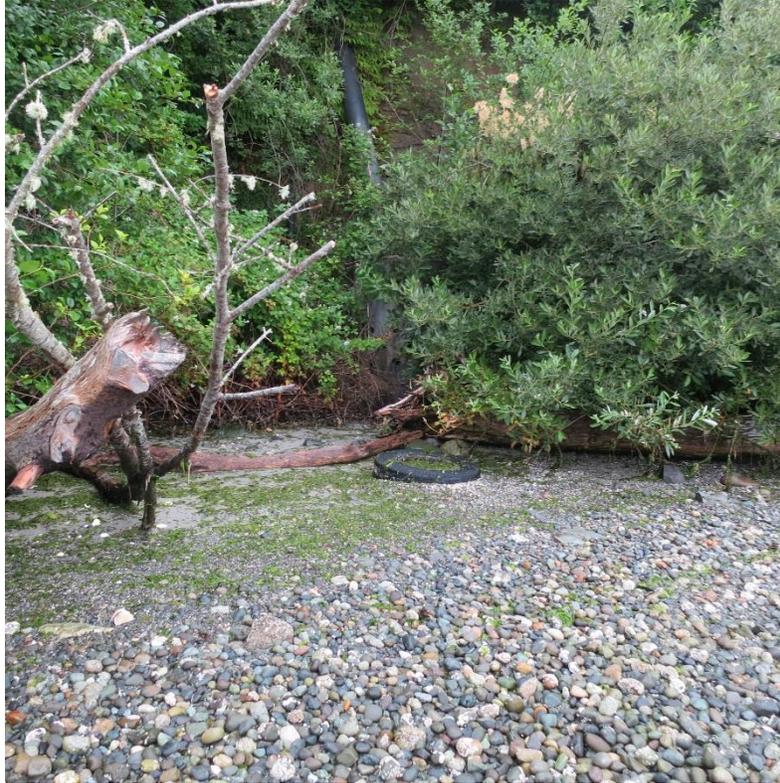
**Pope Way Outfall – July 13, 2017
(outfall structure behind driftwood and vegetation)**

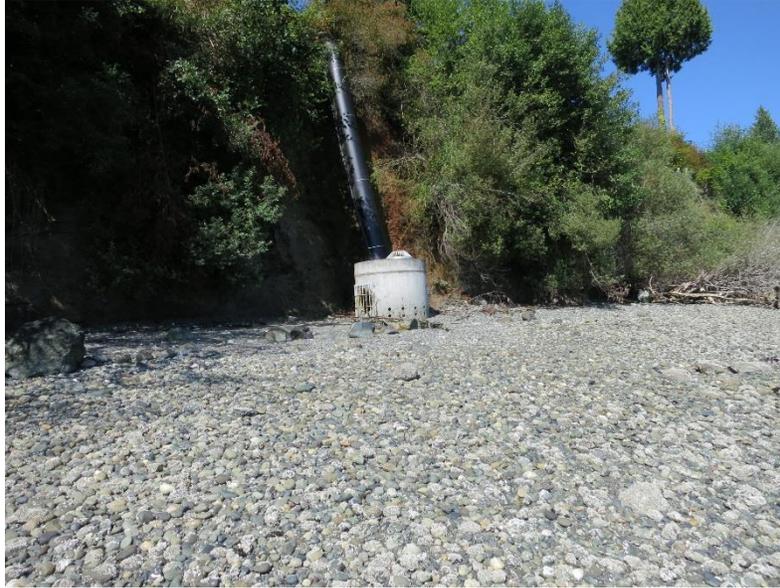
The Libby Court Outfall structure was constructed in 2004. The structure consists of a 32-inch-diameter HDPE overbank discharge pipe and a 60-inch-diameter concrete catch basin/diffuser structure on the beach adjacent to the bluff. The outfall structure including overbank pipe is in good condition. The condition of the beach at the base of the structure has not changed significantly since 2013. The structure does not need cleaning at this time. The bank immediately behind the overbank pipe and outfall structure does not appear to have changed significantly since 2013. The fence at the top of the bank that was installed at the time the outfall was constructed appears to be stable, with no significant change in alignment since 2013.

Libby Court Outfall – August 20, 2013

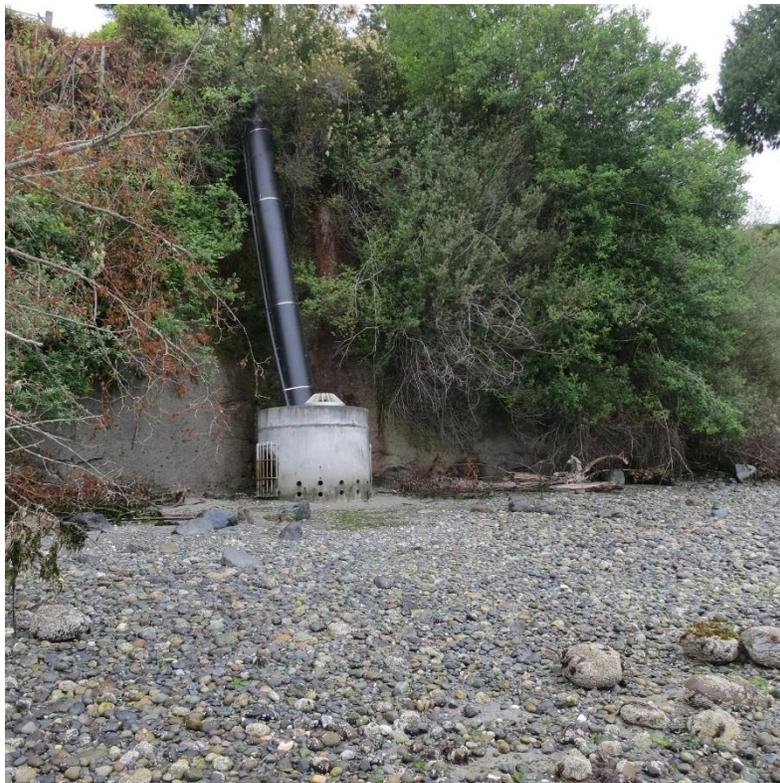
Libby Court Outfall – July 13, 2017

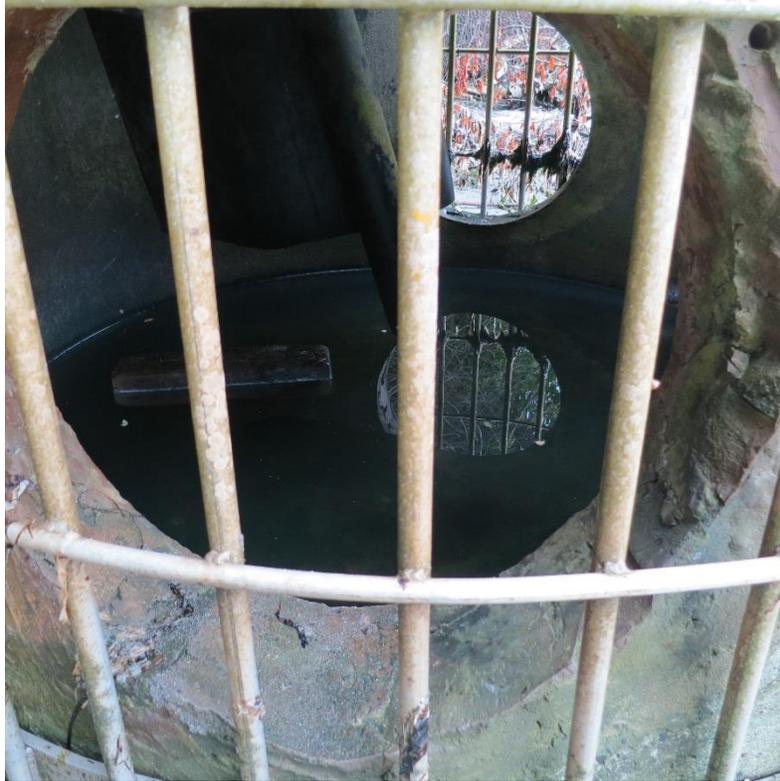
Interior Libby Court Outfall – July 13, 2017

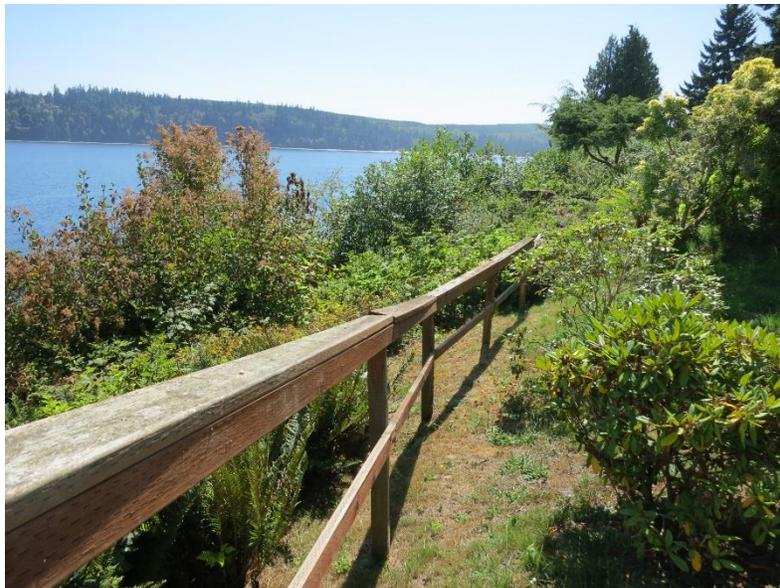
Libby Court Outfall Top of Bank – August 20, 2013

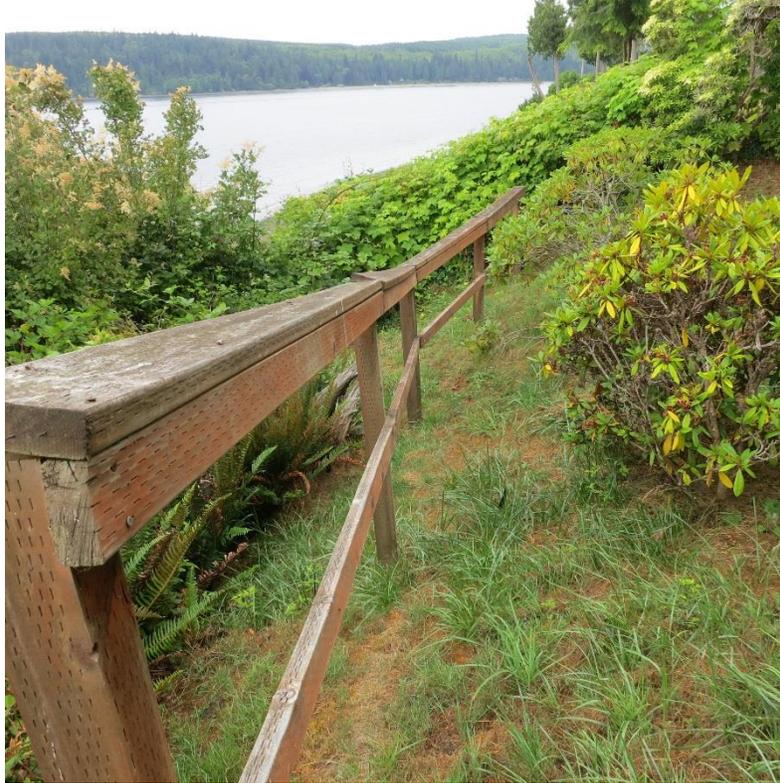
Libby Court Outfall Top of Bank – July 13, 2017

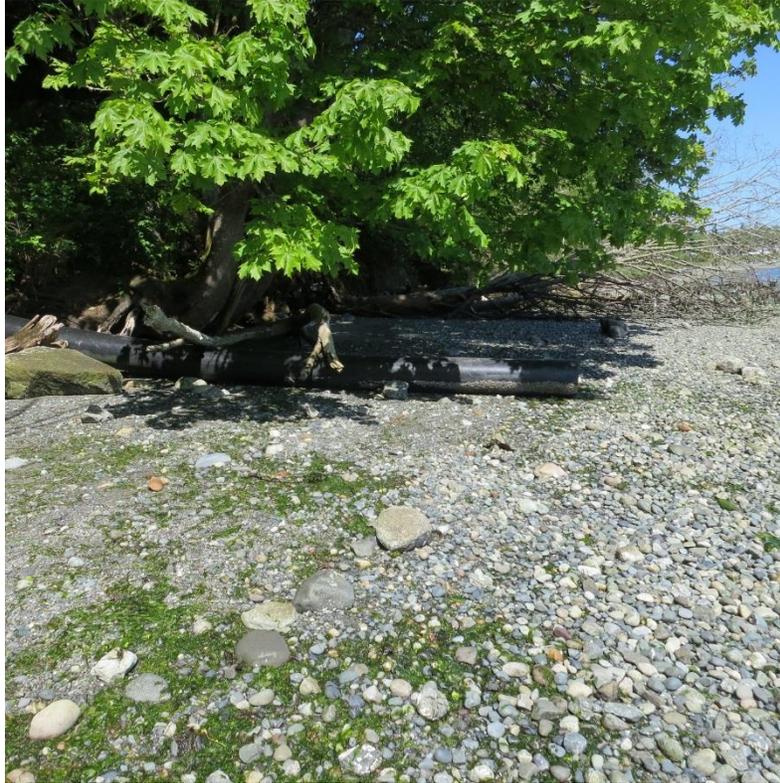
This 18-inch-diameter HDPE outfall was not previously known to the District. The LMC does not have any information regarding the culvert. It appears that flow from Basin E1 (northeast end of Jackson Lane) and Oak Bay Road is conveyed between 81 and 101 Montgomery Court, and is discharged along with flow from Basin E2 (Montgomery Court north from Montgomery Lane) to a catch basin in front of 81 Montgomery Court then into the outfall. The culvert pipe appears to have been installed below grade on the LMC parcel. The condition of the pipe at the outfall is excellent. There is no indication of erosion or potential for damage to the outfall at the beach. The beach walk on May 23 terminated at this outfall since we thought this was the outfall from the north end of Montgomery Court.

**Montgomery Court Outfall – May 23, 2017
(between 70 and 120 Montgomery Court)**

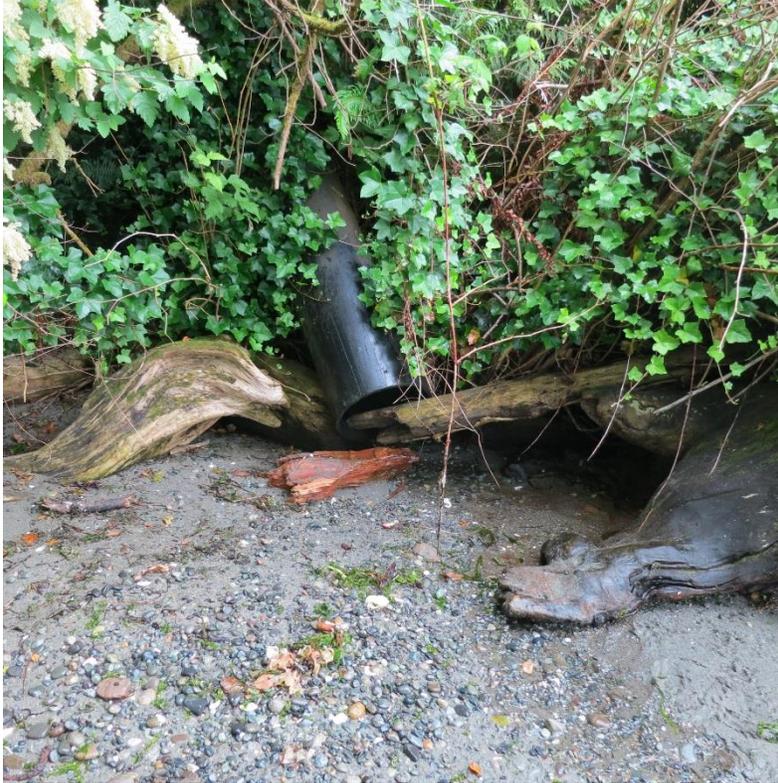
This 18-inch-diameter HDPE outfall collects drainage from Basin C2 in the north portion of the District (gully between Jackson Lane and Foster Lane, Oak Bay Road, and the north end of Montgomery Court). This culvert was installed by homeowners on an LMC parcel. The outfall was designed by Dick Reagan, P.E. The outfall daylights at the top of the bank between 192 and 200 Montgomery Court in a thickly wooded area and appears to continue above grade to the beach. The condition of the pipe at the outfall is excellent. There is no indication of erosion or potential for damage to the outfall at the beach.

**Montgomery Court Outfall – July 13, 2017
(between 192 and 200 Montgomery Court)**
