## MEMORANDUM

TO: COMMISSIONERS  
FROM: NANCY LOCKETT, P.E.  
DATE: MAY 6, 2021  
SUBJECT: BEACH OUTFALL RECONNAISSANCE ON  
APRIL 1, 2021  
PORT LUDLOW DRAINAGE DISTRICT,  
JEFFERSON COUNTY, WASHINGTON  
G&O #21429.00

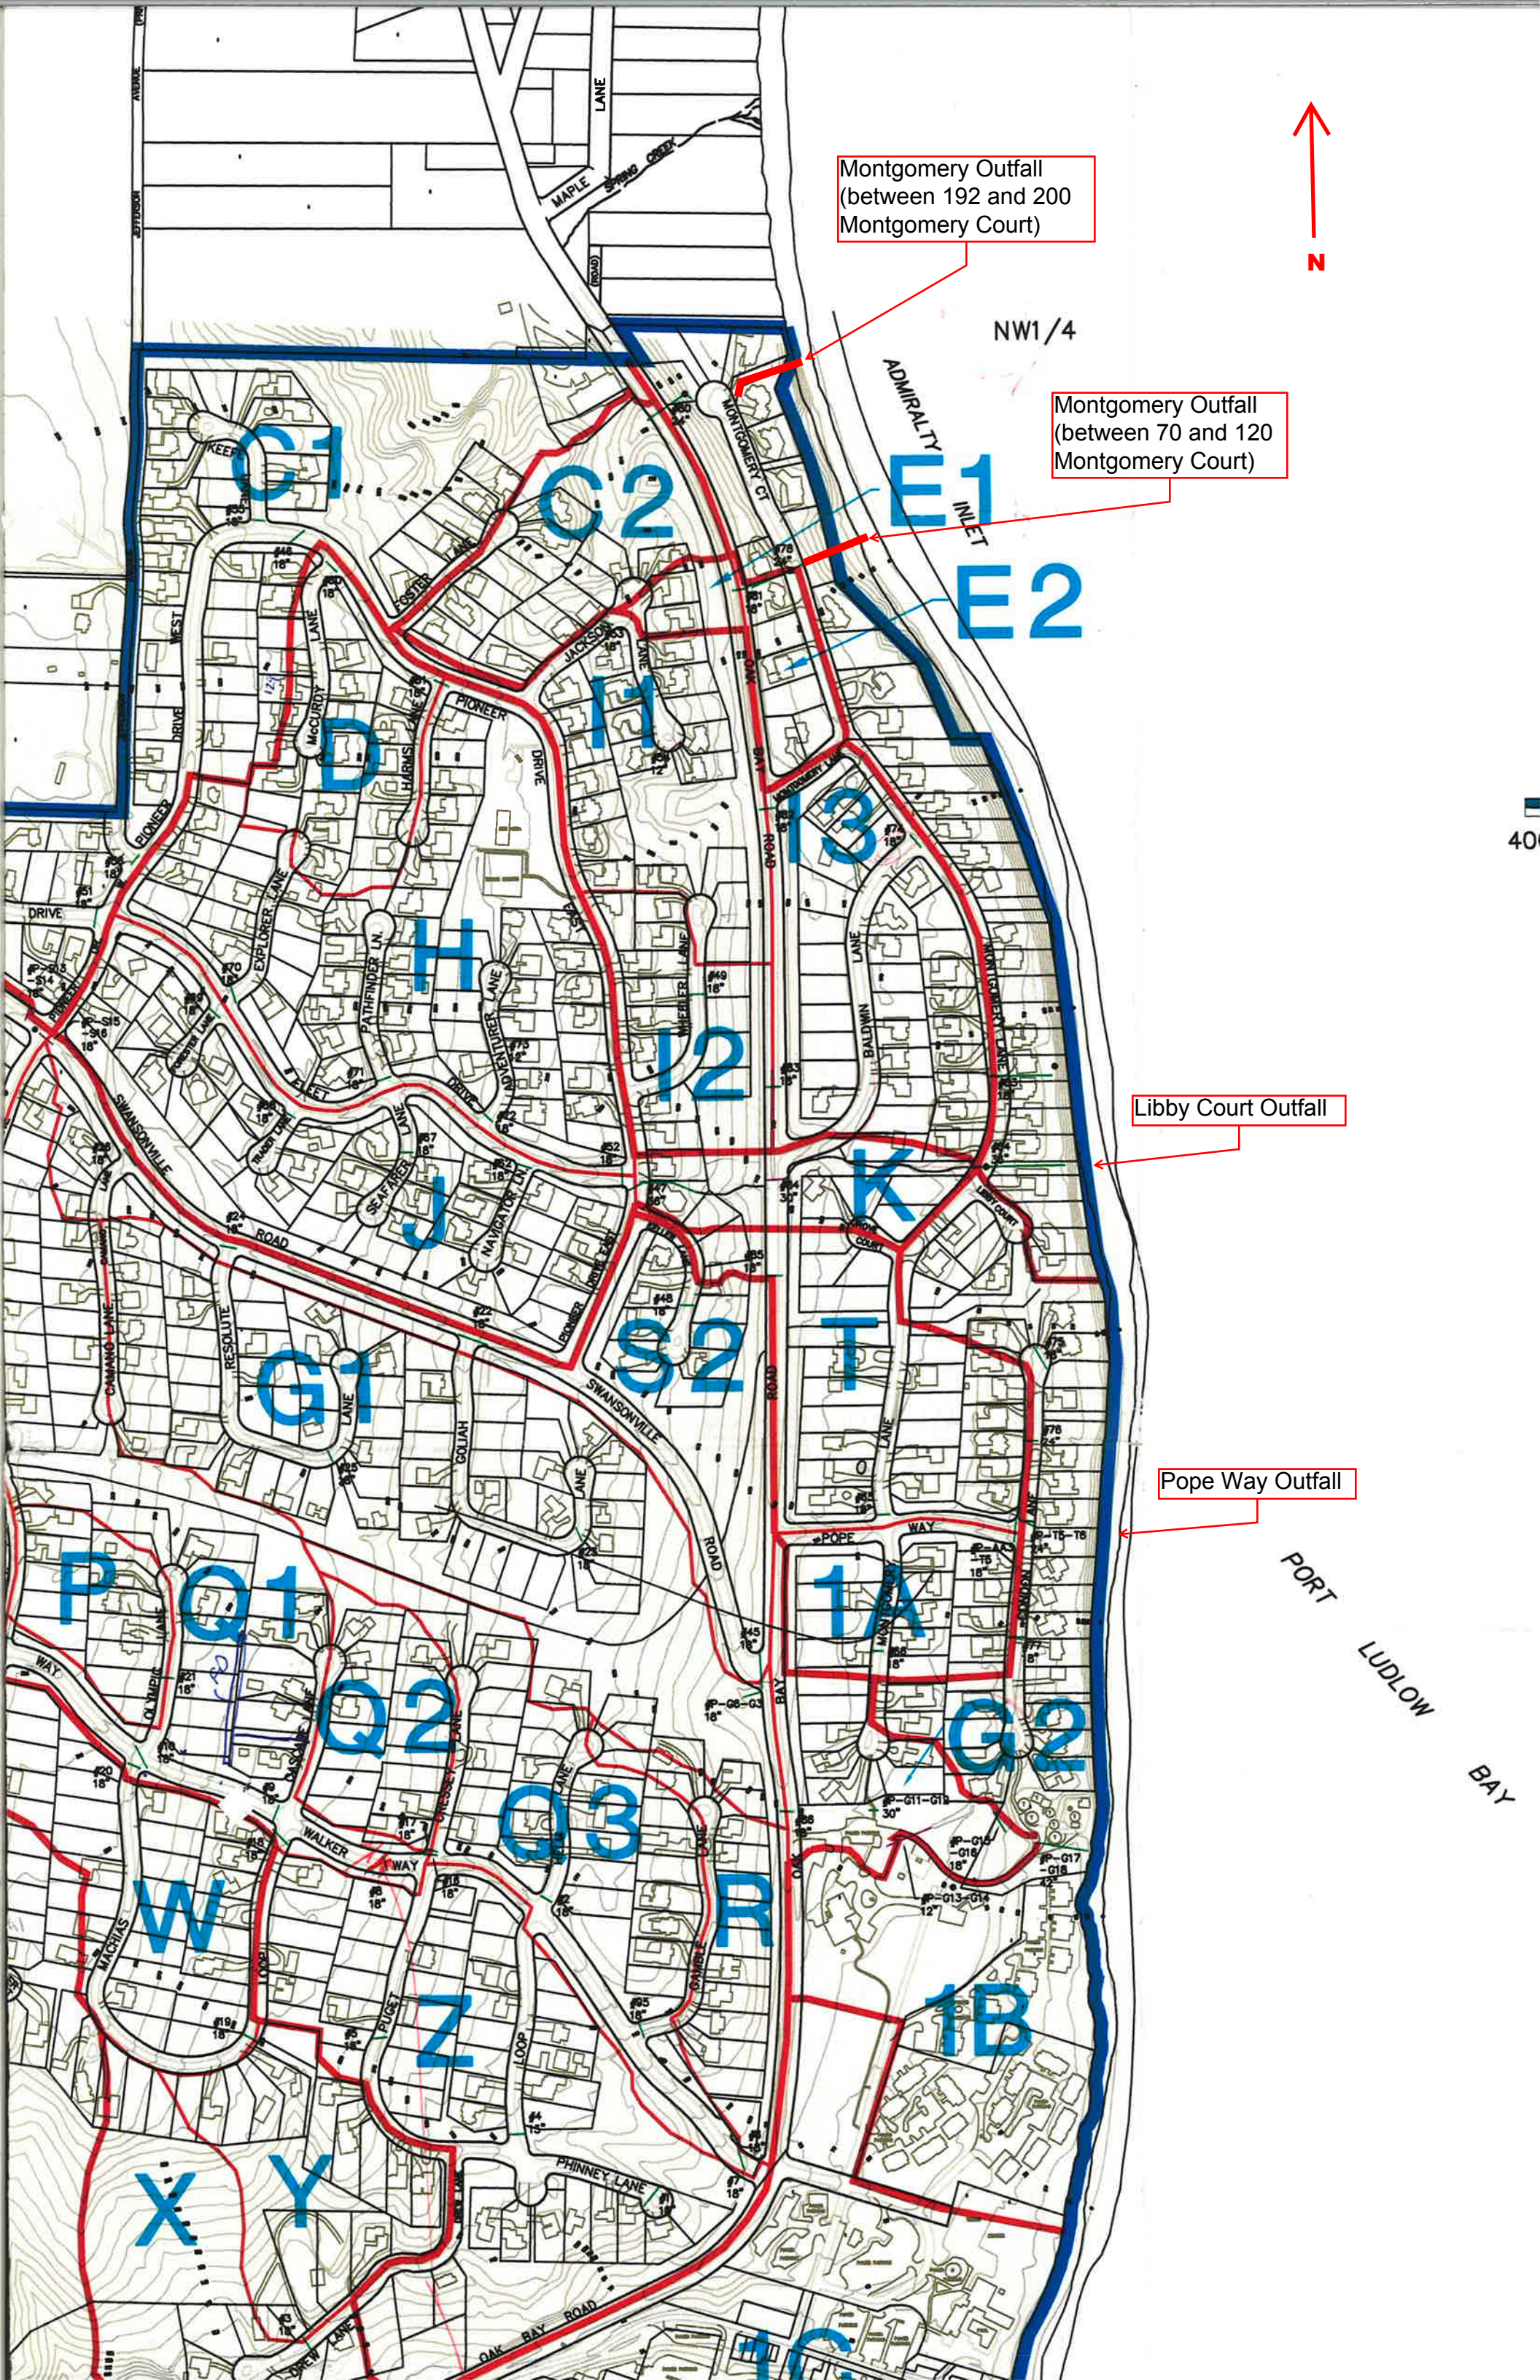
Montgomery Outfall  
(between 192 and 200  
Montgomery Court)

Montgomery Outfall  
(between 70 and 120  
Montgomery Court)
