MEMORANDUM

TO: COMMISSIONERS
FROM: NANCY LOCKETT, P.E.
DATE: SEPTEMBER 11, 2017
SUBJECT: BEACH OUTFALL RECONNAISSANCE ON
MAY 23 AND JULY 13, 2017
PORT LUDLOW DRAINAGE DISTRICT,
JEFFERSON COUNTY, WASHINGTON
G&O #17426.00

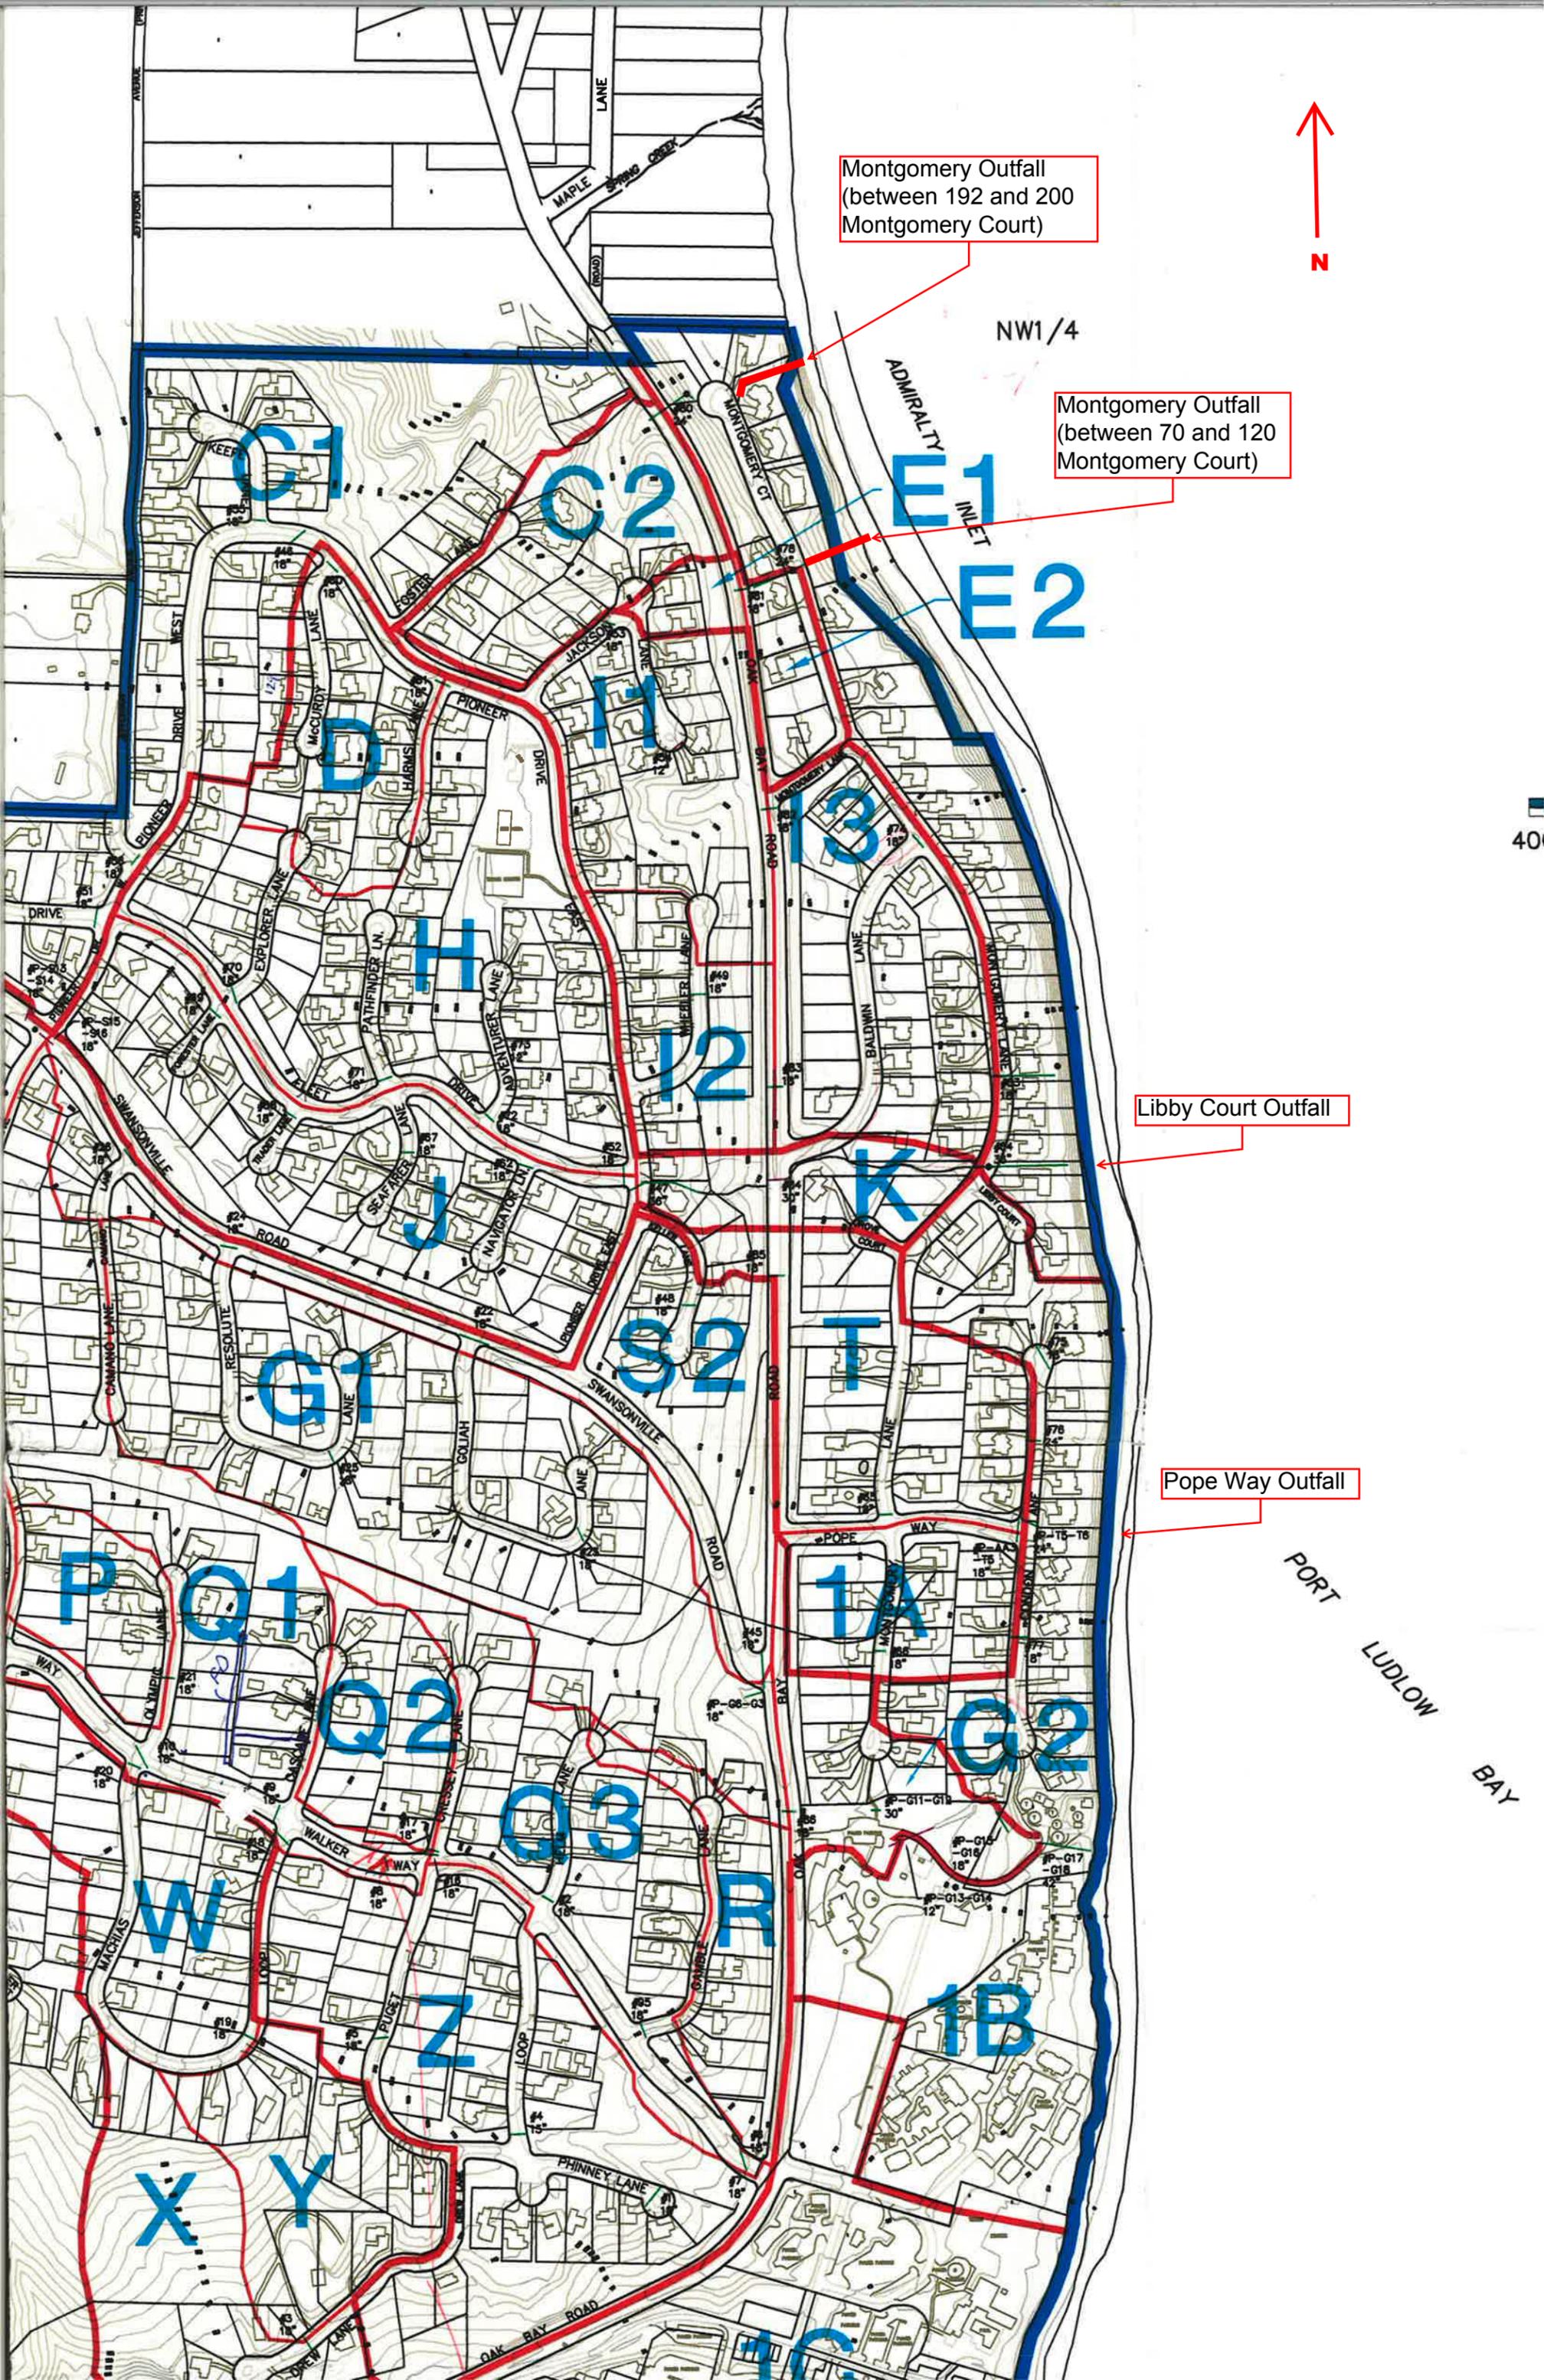
Montgomery Outfall
(between 192 and 200
Montgomery Court)

This 18-inch-diameter HDPE outfall collects drainage from Basin C2 in the north portion of the District (gully between Jackson Lane and Foster Lane, Oak Bay Road, and the north end of Montgomery Court). This culvert was installed by homeowners on an LMC parcel. The outfall was designed by Dick Reagan, P.E. The outfall daylights at the top of the bank between 192 and 200 Montgomery Court in a thickly wooded area and appears to continue above grade to the beach. The condition of the pipe at the outfall is excellent. There is no indication of erosion or potential for damage to the outfall at the beach.
